The Life of the Transformer is the life of its insulation system

Transformer Failure caused by contaminated insulating oil

Failure of 11/0.4 kV: 800 KVA Transformer

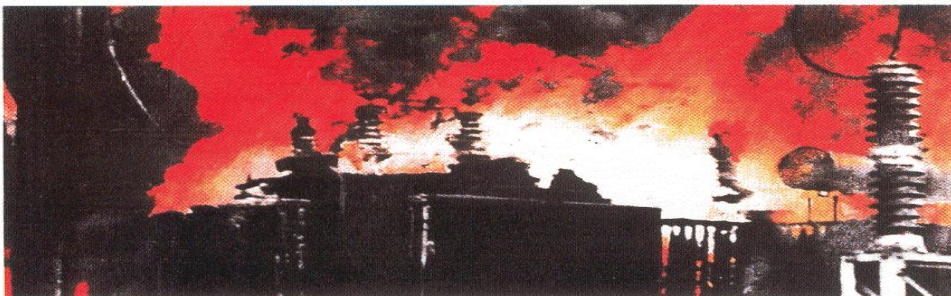
This transformer failed (and so did its owner).

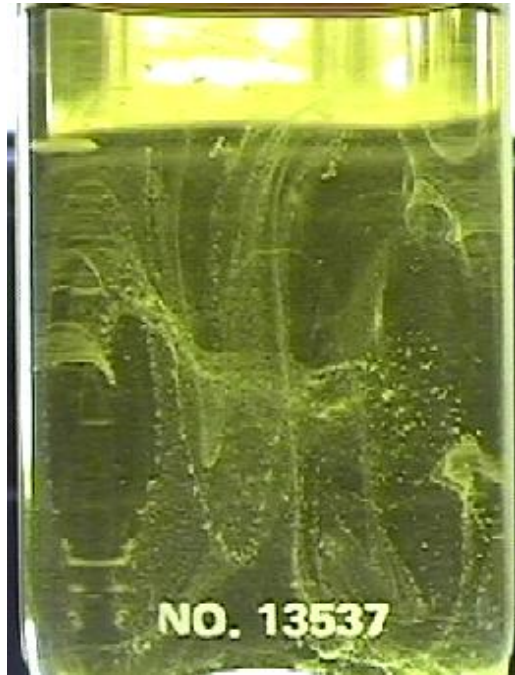
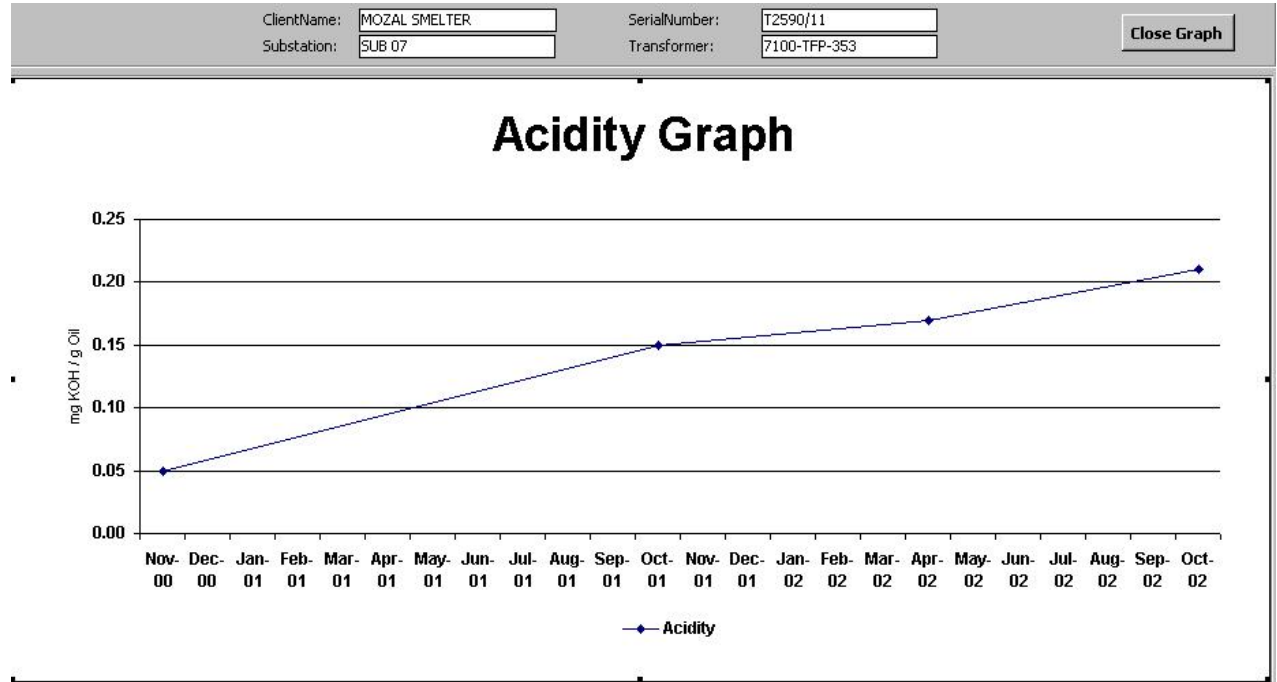
Substation Transformer
SUB 07 7100-TFP-353

SerialNumber T2590/11 **SamplingDate** 17-10-2002 **Water** 21 **kV** 48 **Acidity** 0.21

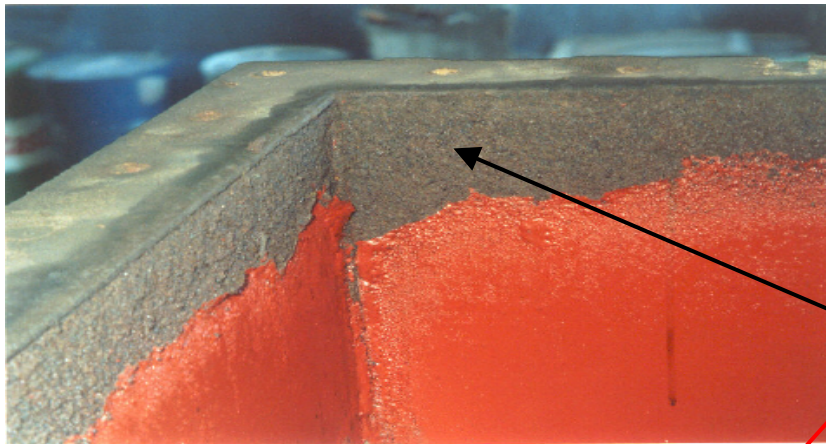
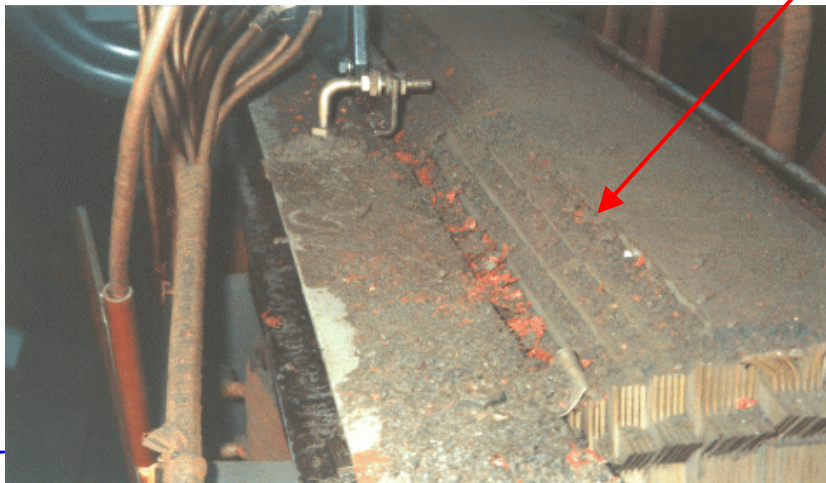
Sappi Fine: Paper Mill

Analysis/Diagnosis: Insulating oil failed tests indicating a sludging condition

Note: This level of acidity can induce corrosion

Findings: Internal corrosion/sludge caused by excess water and Acidity

Note: A common problem with Non Conservator Type Transformers

Recommended: Removal from service for oil replacement/purification with internal flushing

Savings: The unit was properly repaired at a works facility

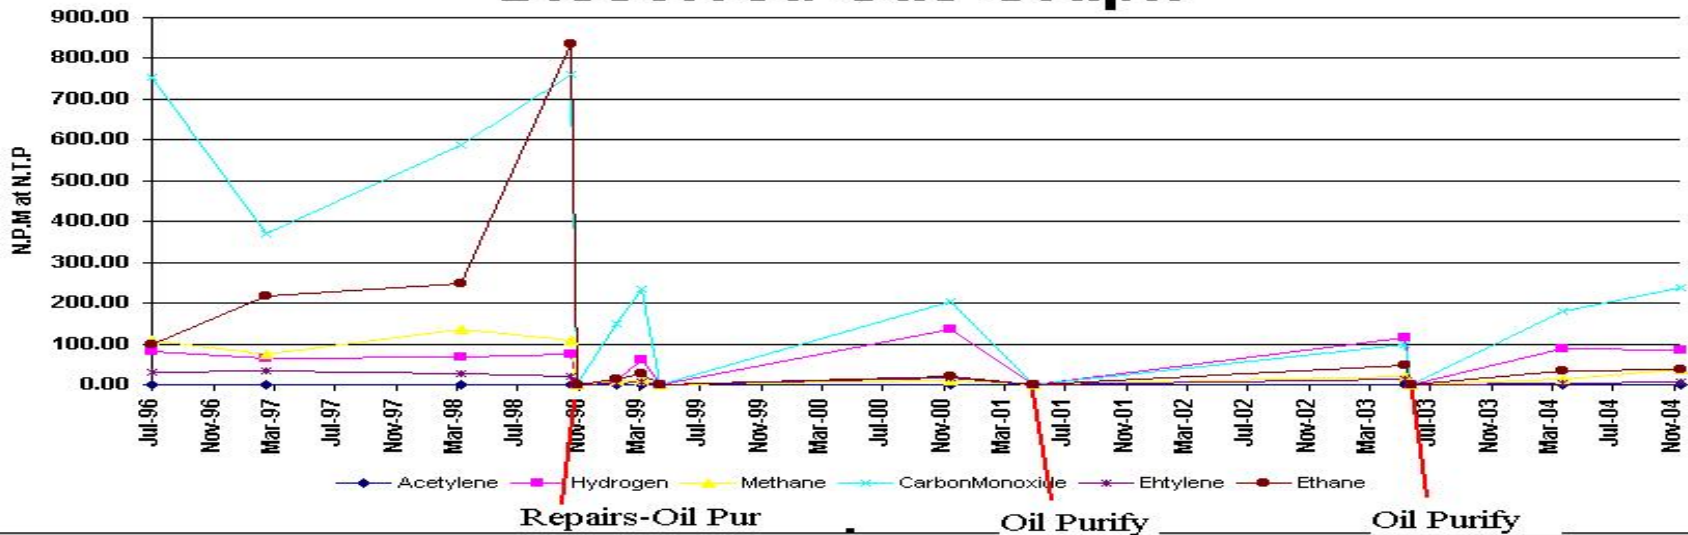
Dissolved Gas Graph

The Dissolved Gas from this point indicates normal internal operation i.e. there has been no significant production of Fault Gases.

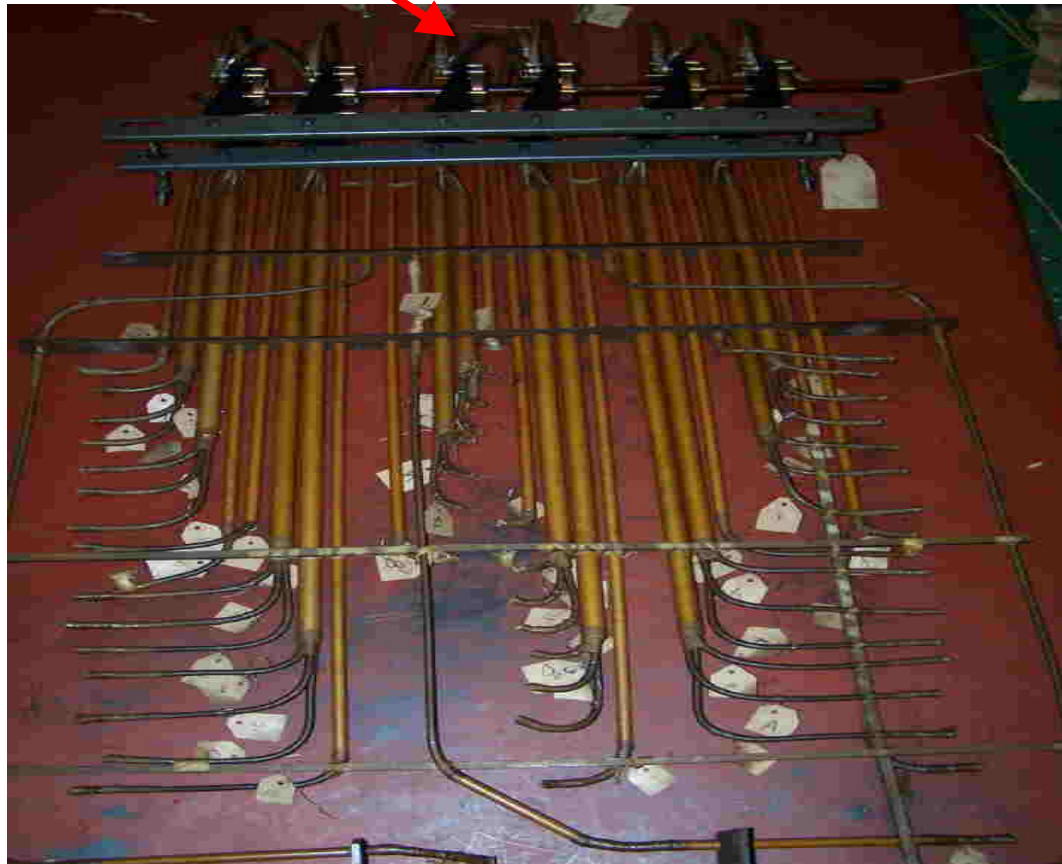
The primary fault was a flash over on the center phase of the Off Load Tap Changer Mechanism

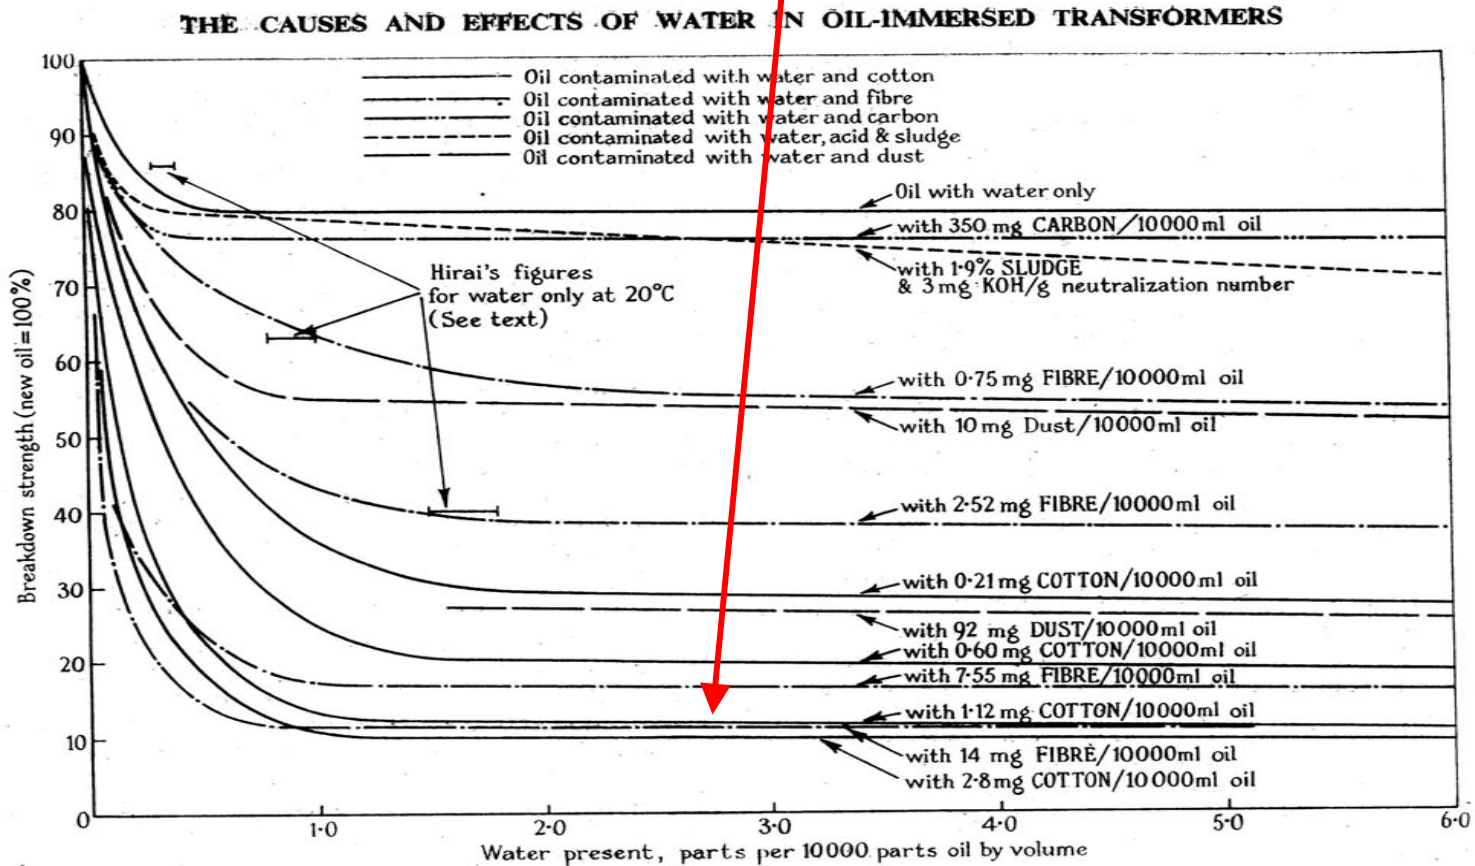
This process of maintenance resulted in contamination of the insulating oil by water and particulate matter. This combination of water and particulate matter lowers the dielectric strength (kV) of the insulating oil unto 90%

Fig. 2.—The effect of various contaminants together with water on the B.D.V. of transformer oil.

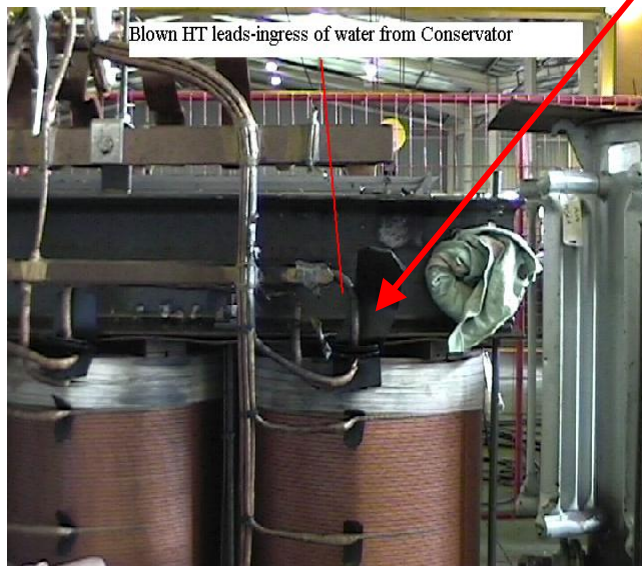
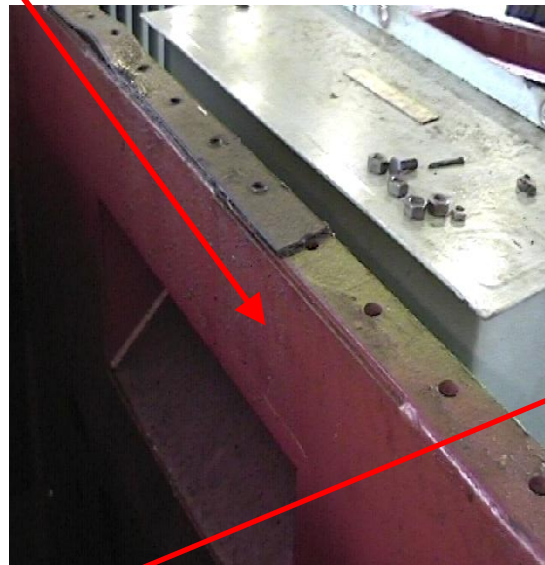
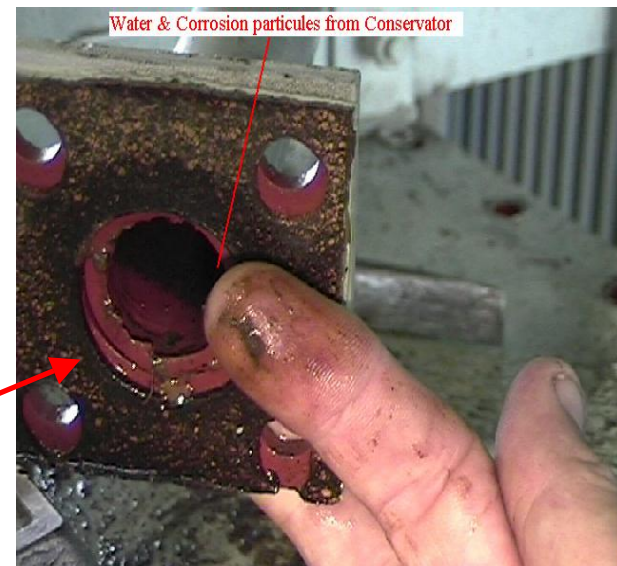
Unit failure 2 days after Oil purification-maintenance

Primary Fault: Arcing from HT leads to the side of the Main Tank: Distance of arc ± 300 mm

Ingresses of contaminated oil into the unit causing failure at the Peak Loading cycle
Caused by improper maintenance: The Conservator tank was not Inspected or purified:

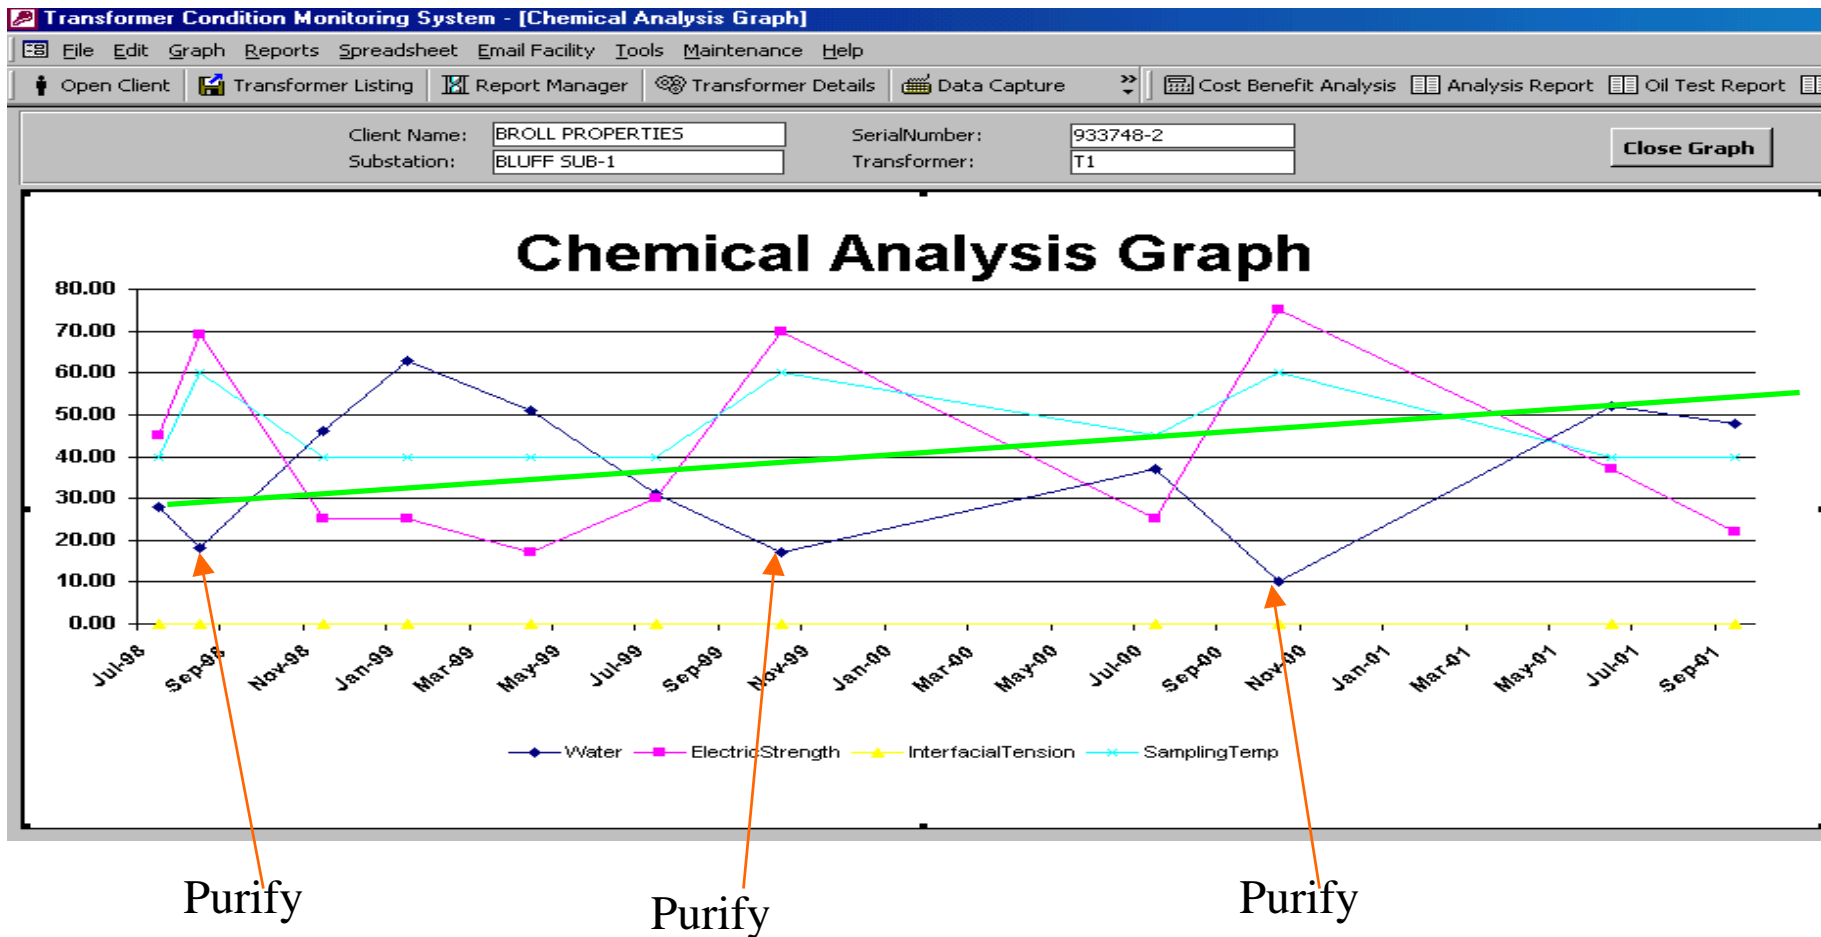
Broll Property : 11 kV : 800 KVA

Water ingress from oil purification: Note Trend Line

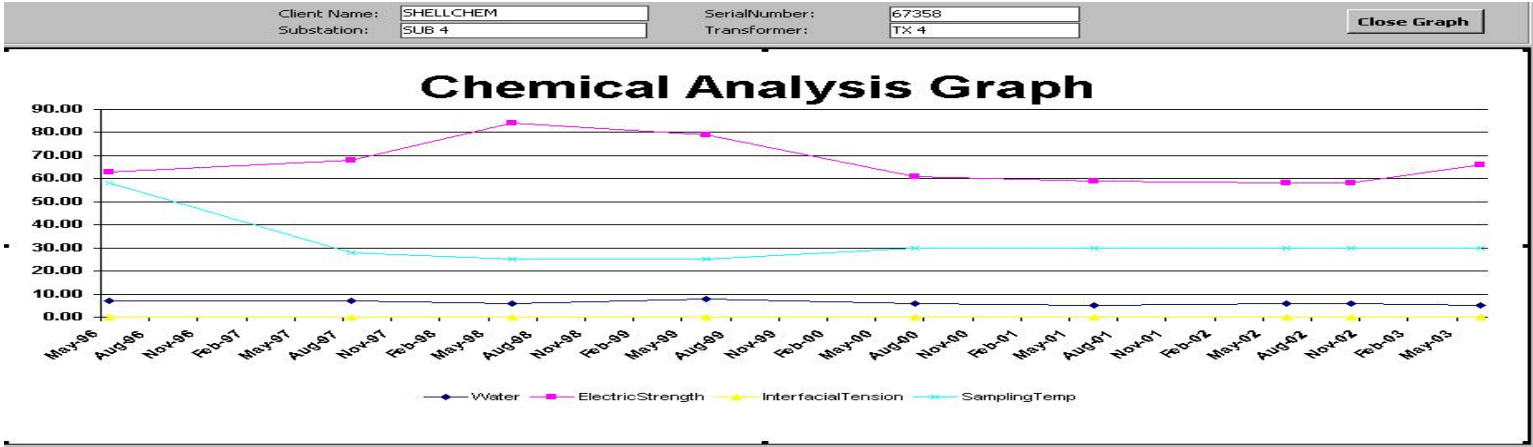
Example: Shellchem showing what is a normal trend

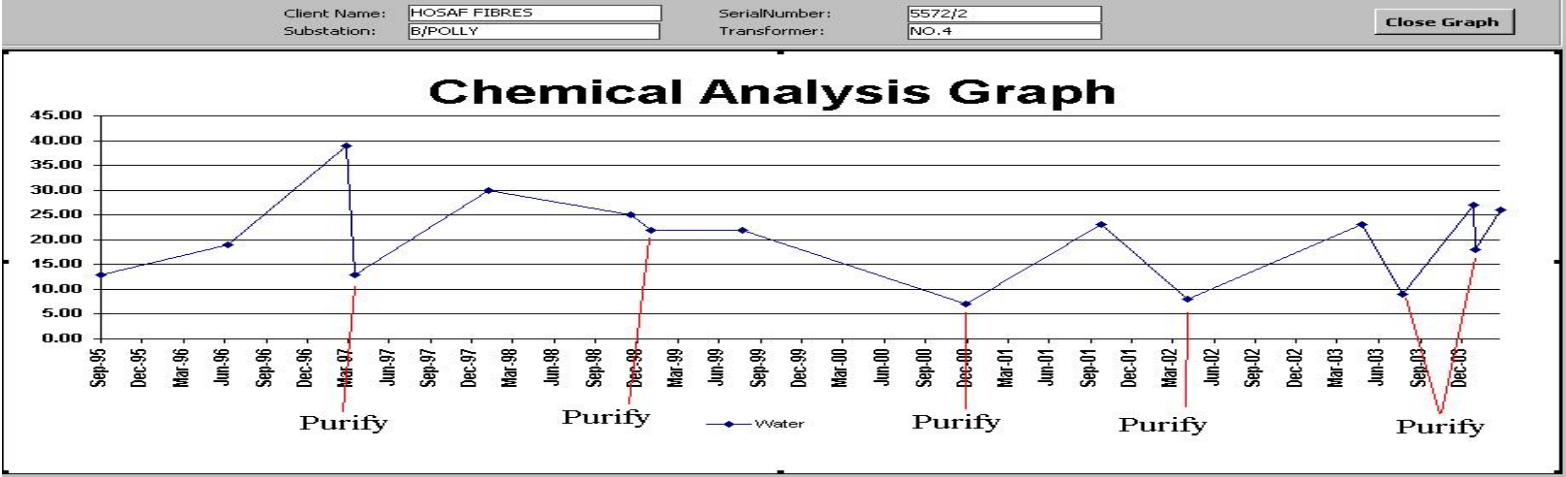
Example: Hosaf showing what trend ?
