# Evaluation of Transformer Solid Insulation

By I.A.R. Gray

Transformer Chemistry Services

## CASE STUDY: INSULATION FAILURE.

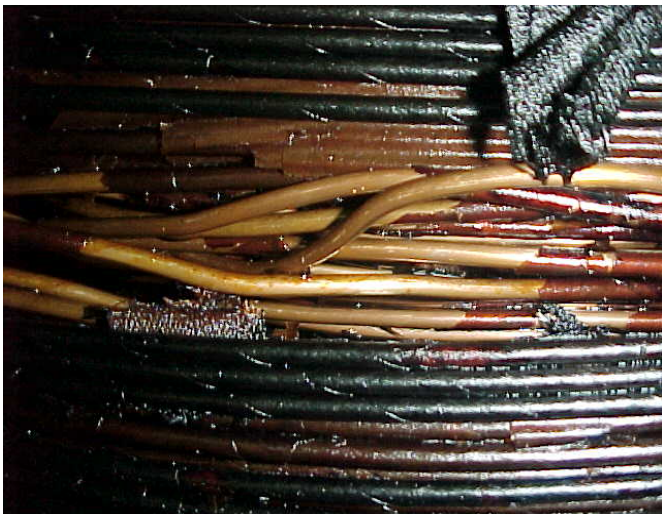
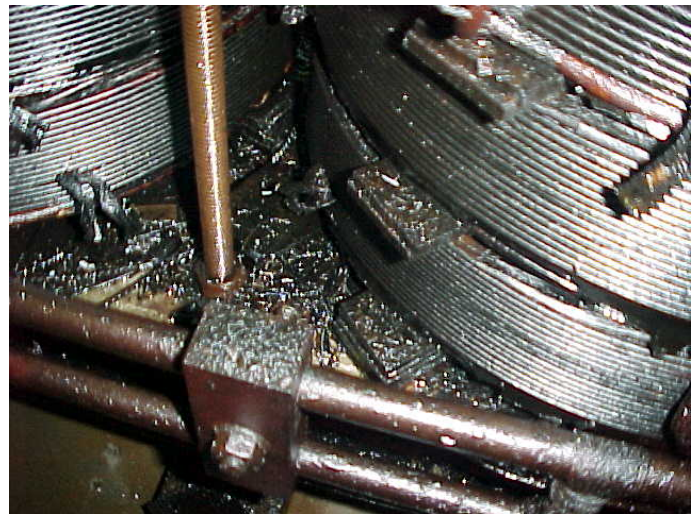
The Furan analysis of 8.97 ppm indicated Extensive paper deterioration. The maintenance history of the transformer revealed that oil replacement and purification took place on 12-03-2000. The Furan production rate was 160 ppb (parts per billion) per month (ppb/month). The Morgan Schafer Company reports that a furan production rate of 25 ppb/month is cause for concern.

The transformer oil analysis indicated a case of advanced paper insulation deterioration. (See Table 3)

The transformer was removed to a works facility and inspected. The paper insulation clearly was at End of life criteria.

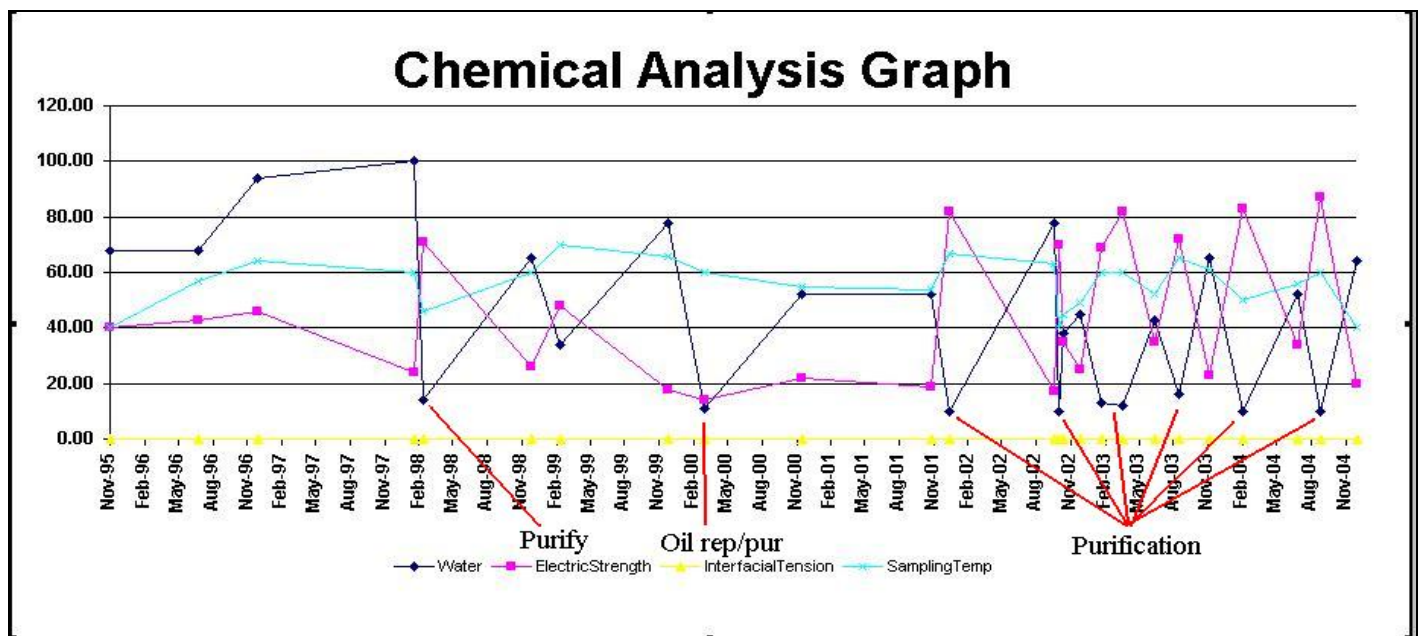
The transformer had undergone oil purification on ten occasions since 1995 in an attempt to remove moisture and improve the dielectric. With oil replacement on 12-03-2000. The oil purification had no effect in improving the oil condition

Assessing the state of the paper insulation is vitally important when considering a maintenance plan for a transformer. In this case a more cost effective maintenance plan would be to remove the transformer to a works facility for Refurbishment.

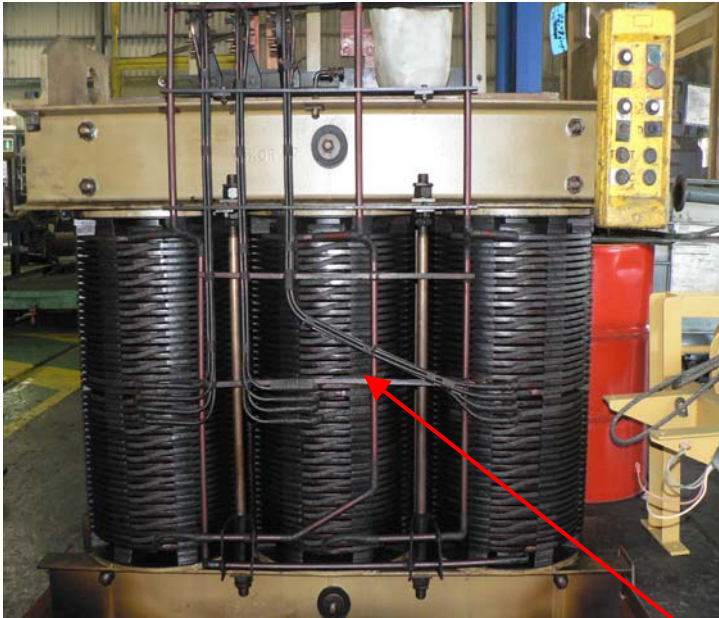
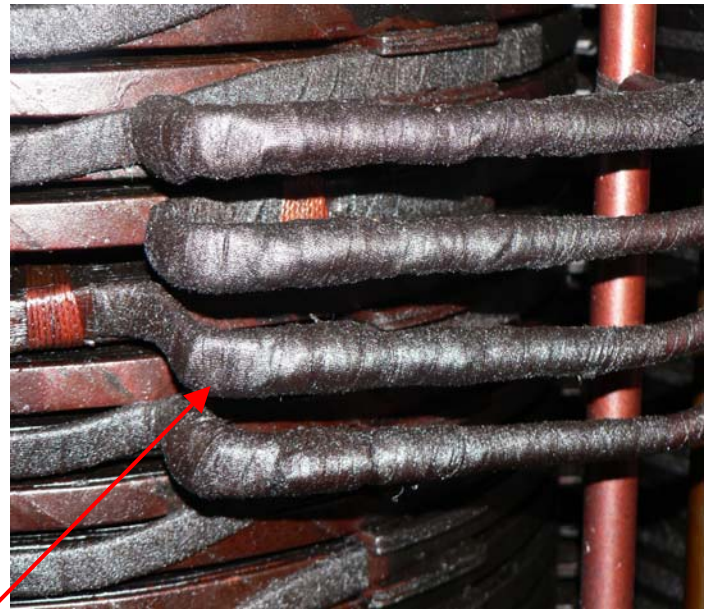
Furan ppm (mg/L)	9.90	>10	End of life criteria
Predicted Degree of polymersation	218	< 250	End of life criteria
Water in paper: % Dry Weight	3.08	2.0 (max)	
Water in paper: Total Litres	7.87

Paper insulation: Extensive deterioration-Serious production rate-316 ppb/month (see Furan). > 25 ppb/month(cause for concern)

**RECOMMENDED: Remove from service for Inspection/Repairs to paper insulation.**

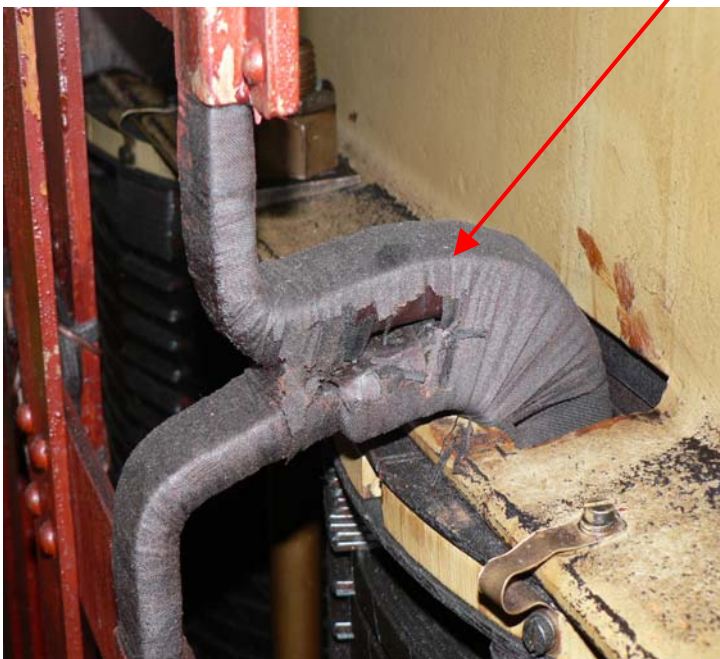
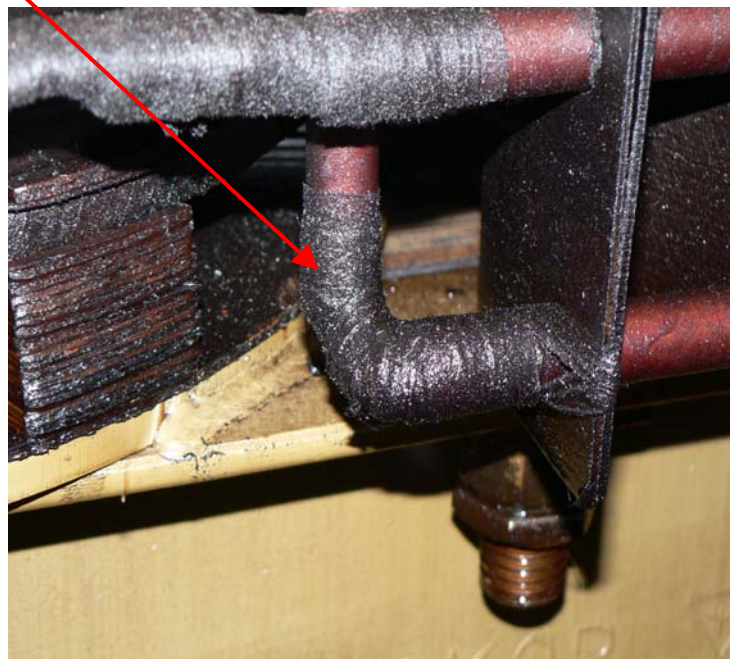
**FINDINGS: Extensive solid (paper) insulation deterioration**

*The transformer was rewound/remanufactured at a works facility and then returned to service under planned conditions avoiding costly in service failure.*

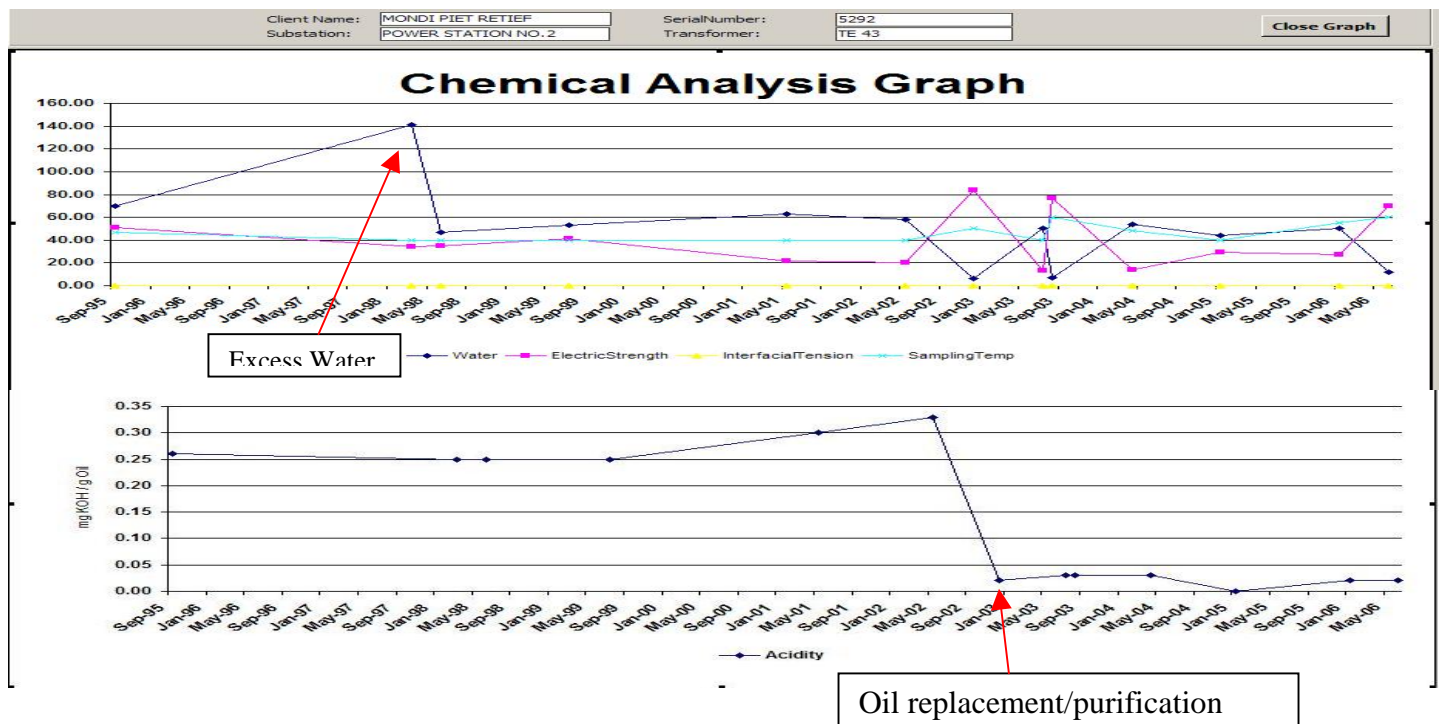
To understand the cause the maintenance history of this unit was reviewed. The graph trends show typical high moisture in oil and acid contents, which cause the paper insulation deterioration. (See table 3)

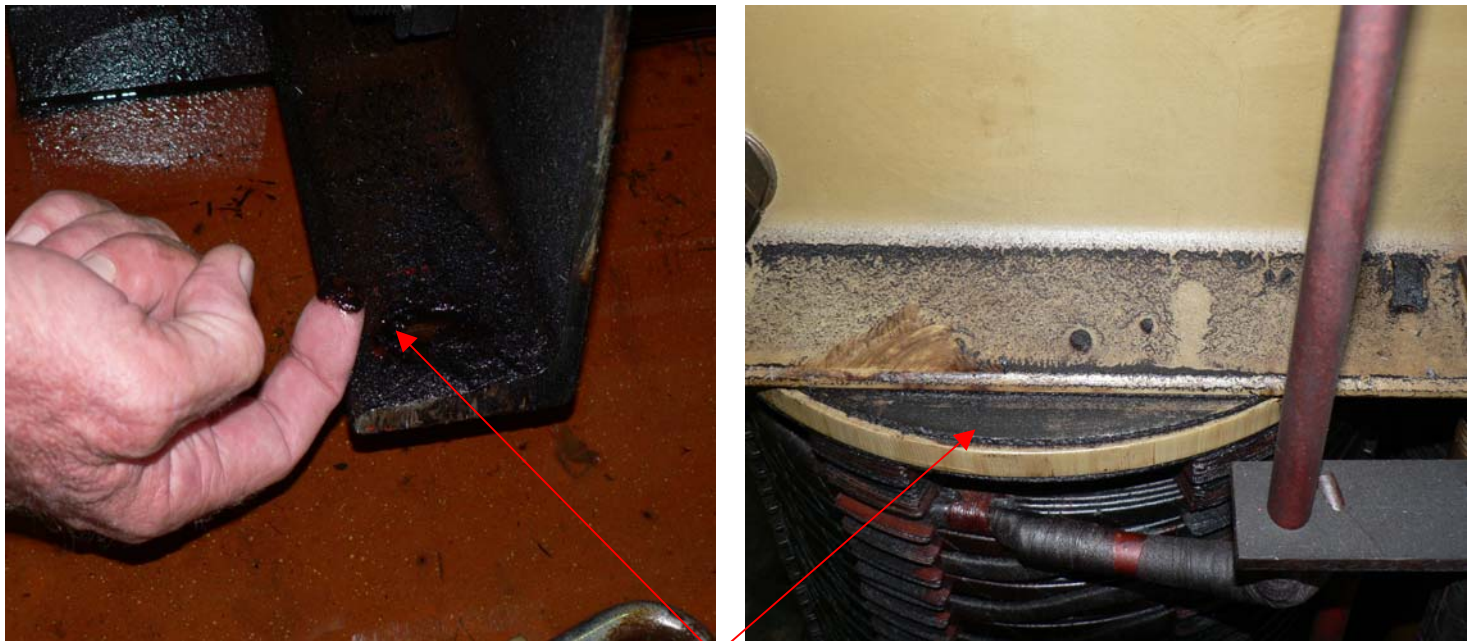
The oil replacement/purification at January 2003 was not done with any internal flushing with sludge remaining in this unit.

Residual Sludge  
By products of oil oxidation
