Practical Experience Gained from Dissolved Gas Analysis at an Aluminium Smelter

Ian.A.R. Gray
Transformer Chemistry Services

The Hillside aluminium smelter is located in Richards Bay, 200 kilometers north of Durban, KwaZulu-Natal province, South Africa. The operation is fully owned and operated by BHP Billiton.

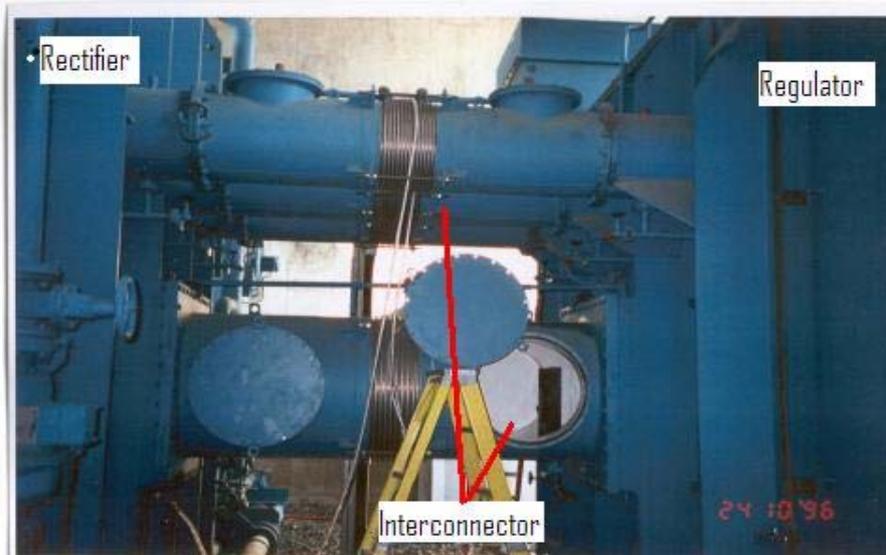
Figure 11-Interconnection system for the Rectifier and Regulator Transformers.

On the 23rd October 2005, a gas alarm was triggered by the Buchholz relay on the Interconnector system. The Interconnector links the Regulator and Rectifier through a system of oil filled compartments using paper insulated copper conductor. This event occurred approximately 6 months after energisation. See Figure 11 showing the how the Rectifier and Regulator Transformers are interconnected; the Cable Housing is to the right of picture.

The OEM suspected a Corona (Partial Discharge-PD) problem on the Cable housing to be the cause of the gas generation. The repair of this kind of fault would involve a lengthy outage with specialist staff and equipment that would have to be flown in from Germany.

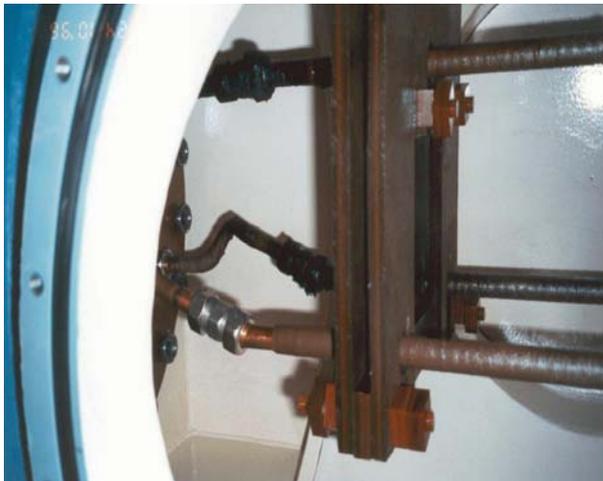
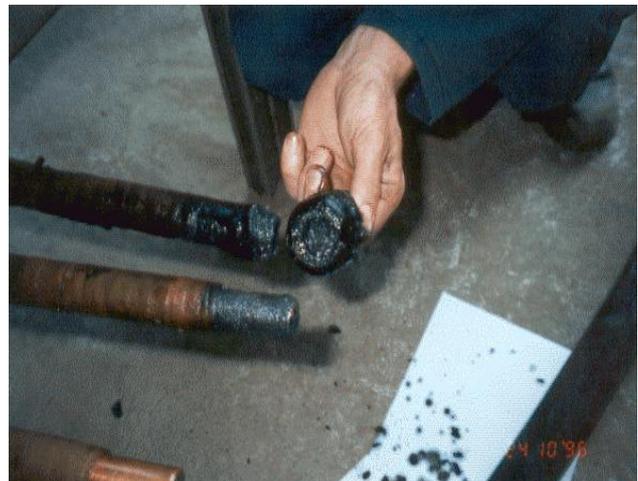
Figure 12-Burnt (overheated) connections

The internal inspection of the Main Chamber found burnt (overheated) connections. See Figures 12A-B
The connections overheated because they had not been tightened to the Manufacturers specification.

The root cause was found to be being non-conforming quality control during installation

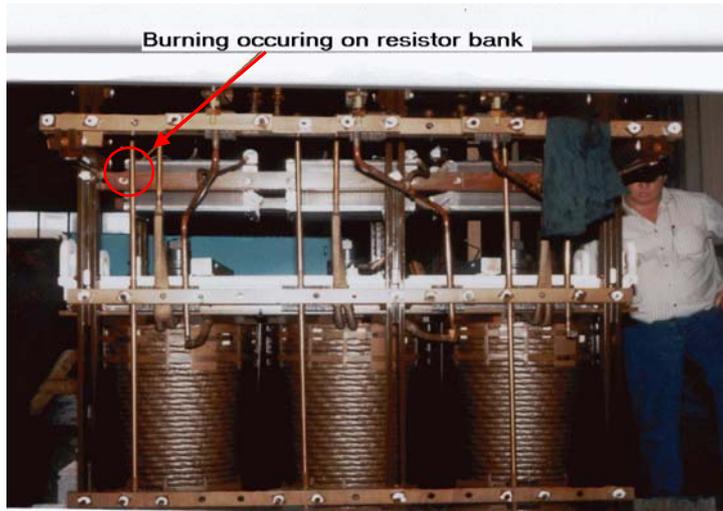
Figure 14-Showing the point on the Resistor bank where the Overheating was occurring.

The internal inspection found overheating and burning on the resistor bank. See Figure 14.

The unit was returned to service after repairs but the root cause had not been established. The initial theory was that the cross sectional area of the metal strips was insufficient for the magnitude of the current.

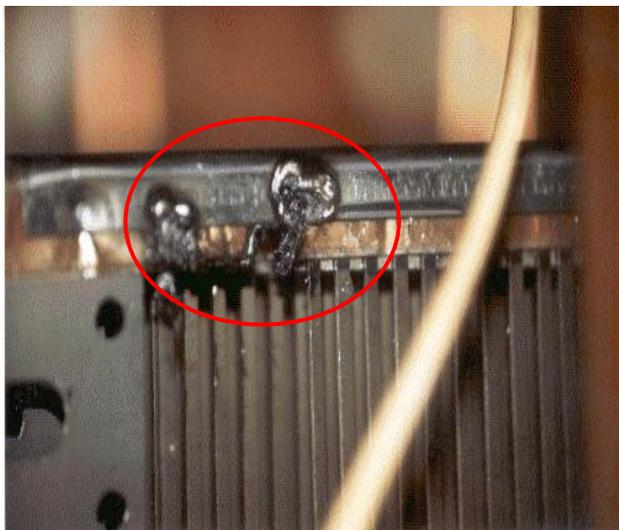
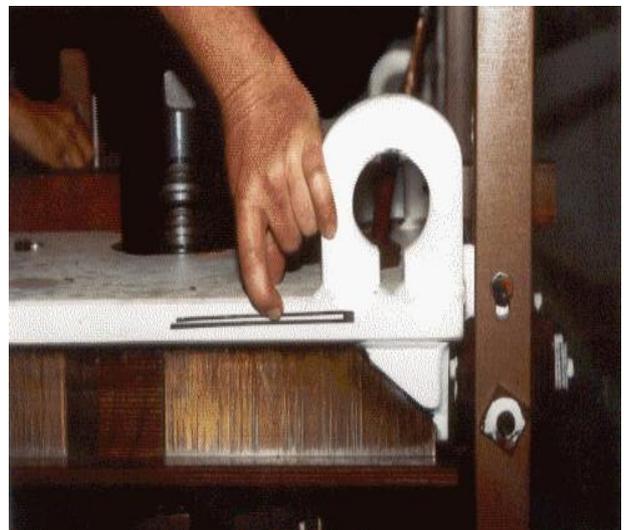
Figure-15 A-showing the actual point of burning on the resistor bank point and 15 B-showing a metal strip that had burnt off the resistor bank.

Figure 15 A-shows the actual point of burning on the resistor bank point and 15 B-shows a metal strip that had burnt off the resistor bank.

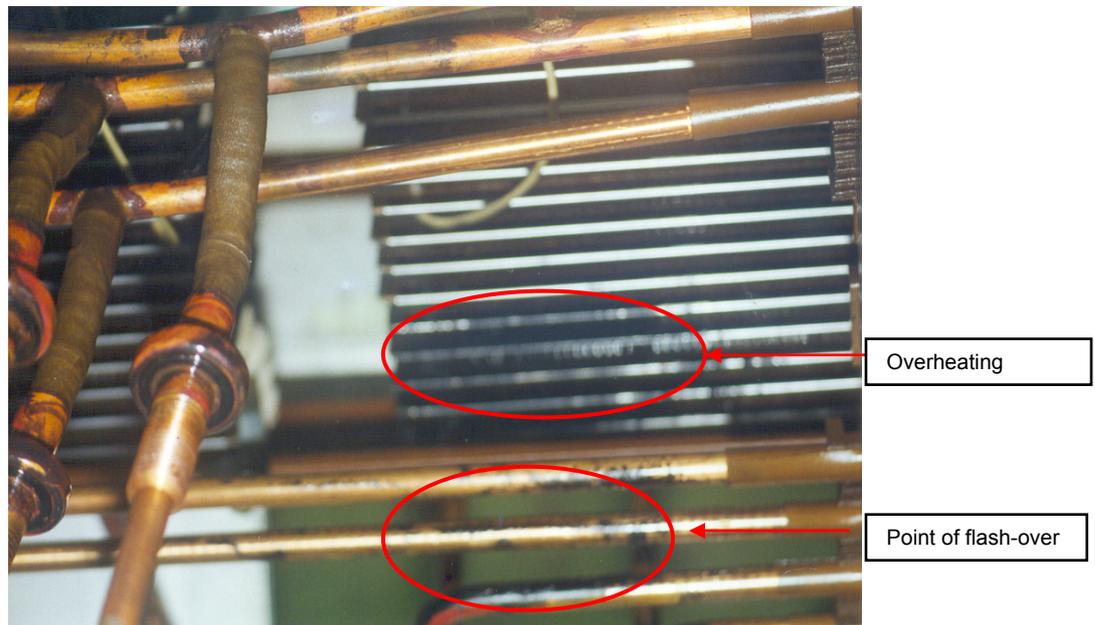
Figure16-Showing the overheating on the resistor bank and the point of flash-over.

The internal inspection found overheating and burning on the resistor bank and a flash-over had occurred on the bare copper conductor above the resistor bank. See Figure 16.

The overheating on the resistor bank as a result of voltage stress caused gas bubble formation. Gas bubbles have a lower dielectric strength than either oil or the oil-impregnated solid insulation under normal conditions. Bubbles therefore can be a source of partial discharge activity or in this case a discharge of high energy. The voltage stress is inversely proportional to the dielectric constant and therefore gas bubbles are much more stressed than the surrounding oil and solid insulation.

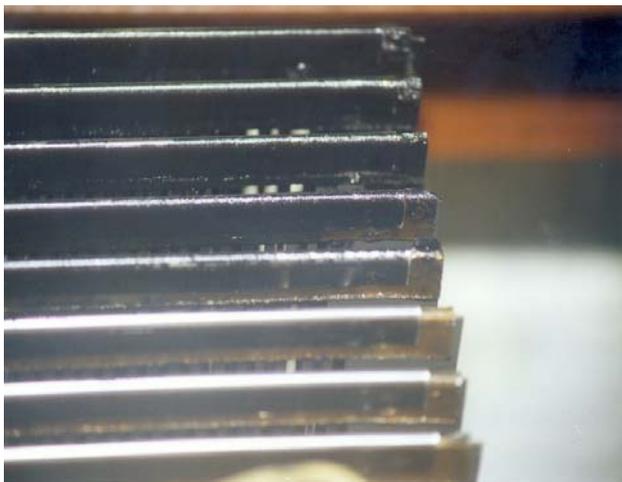
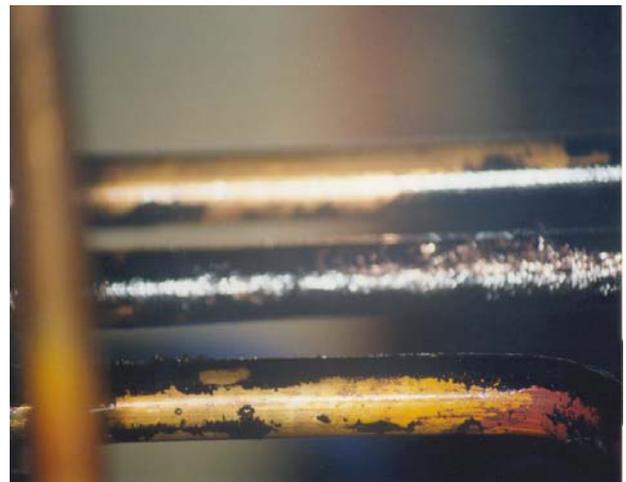
Figure17 A-B Showing the overheating on the resistor bank and the point of flash-over

Figure 17 A-shows the actual point of overheating on the resistor bank point and 17 B-shows the point of flash-over with the carbonisation on the copper conductor.

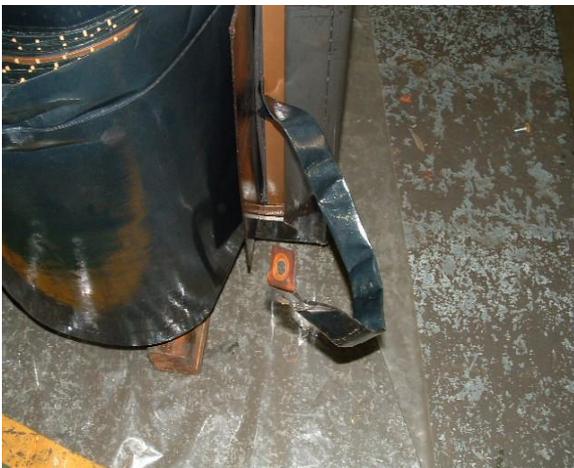
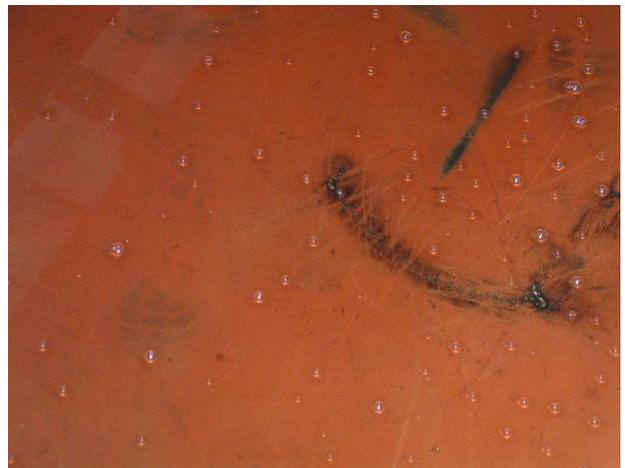
Figures 22 A and B showing the findings

Carbon marks were detected over the bottom core-clamp insulation-See Figure 22B.

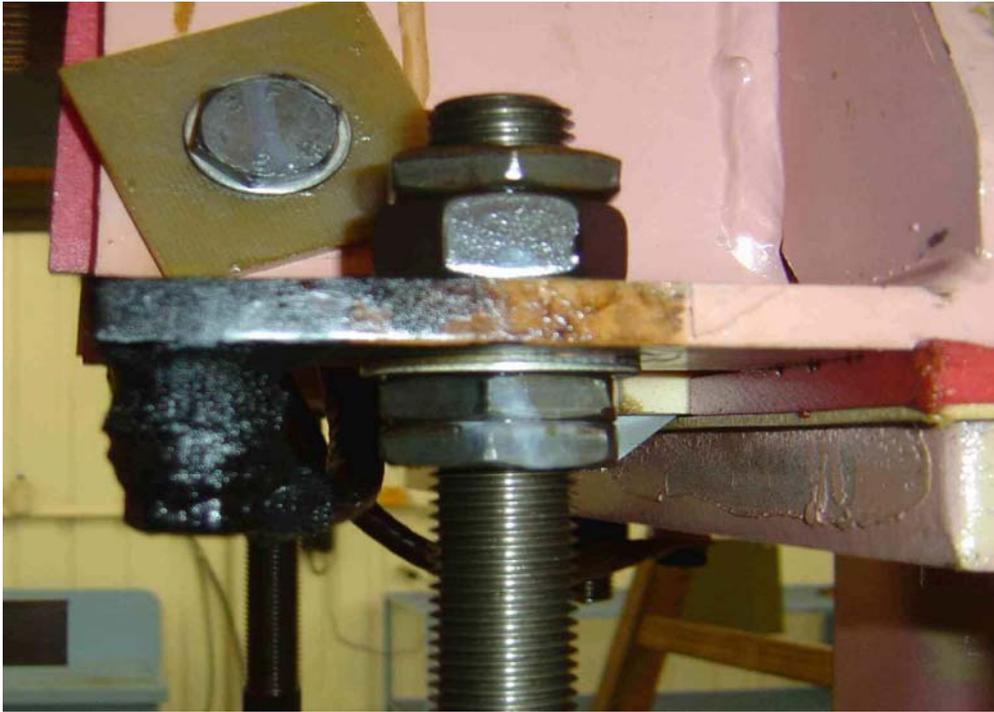
One clamping bolt was identified as having incorrect insulation washers. That is, insulation on the one side of the hole through the frame but none on the other side.

Figure 26-Termination for potential connection became a hot spot due to circulating current

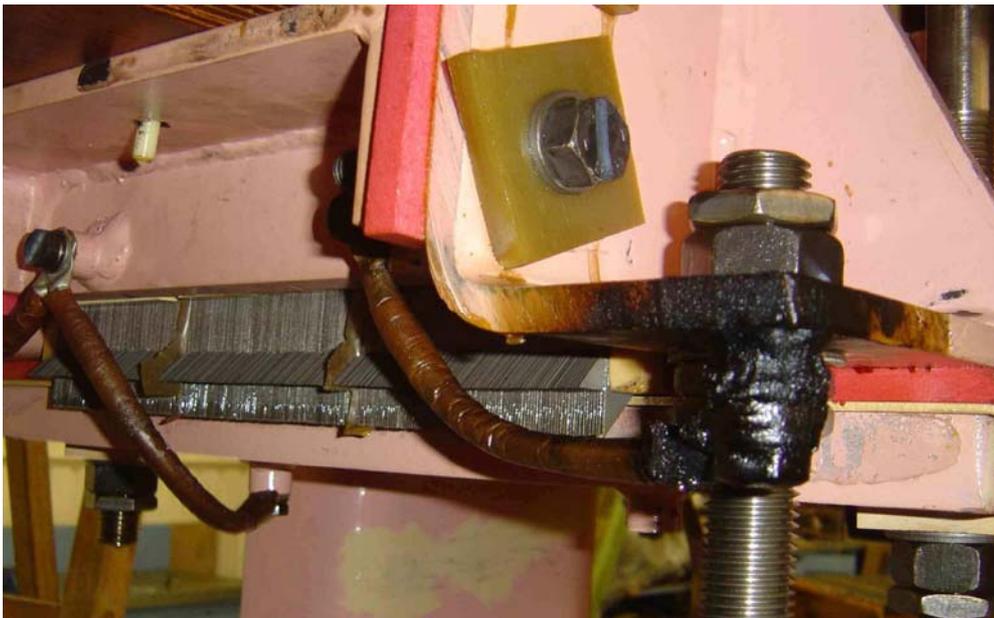
Figure 27-Second view of hot spot - bad connection for circulating current.

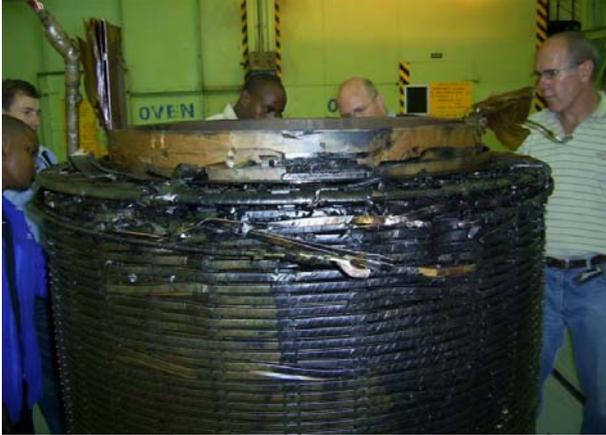
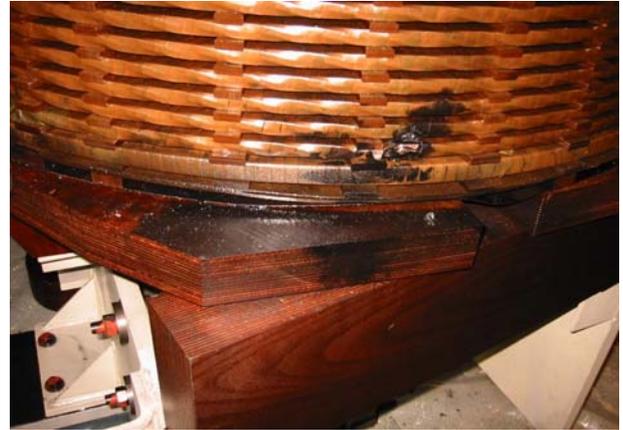
Figures 29 A and B-Show the damage

The flash mark on the A-phase LV winding was on the outer surface of the disc at the bottom of the winding. The blocks underneath the winding showed movement as a result of the flash over between the A- phase HV winding and core. See Figure 29B

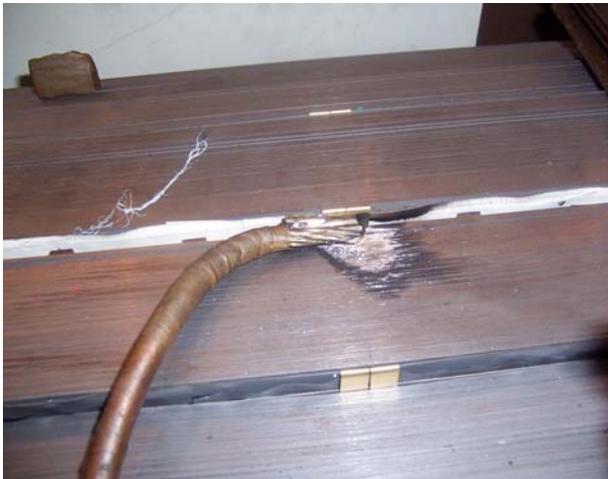
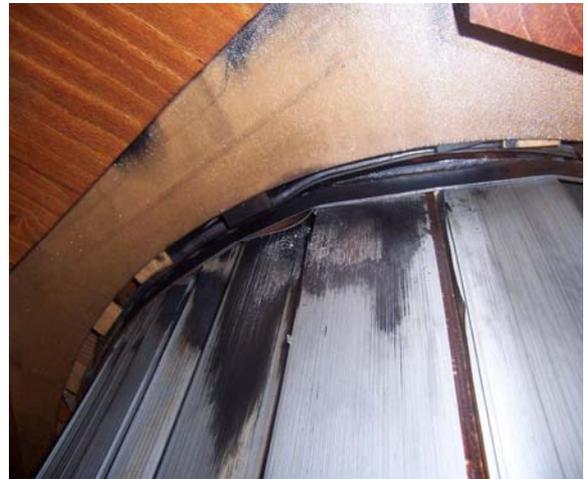
Figures 30 A and B show the sites of Overheating

Burning in the vicinity of the top core earth strap between A and B phases as a result of the fault currents during the HV flash over. See Figure 30A.
Overheating of the Core. See Figure 30 B.

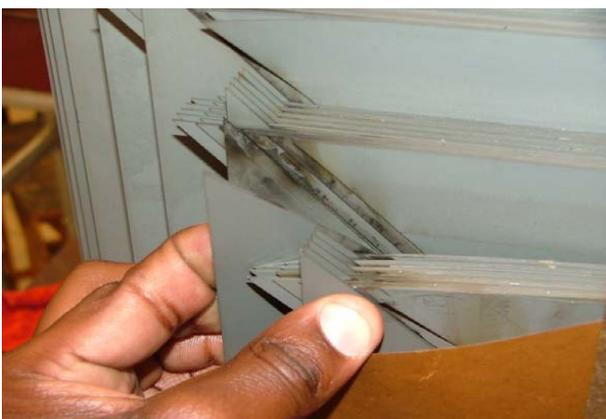
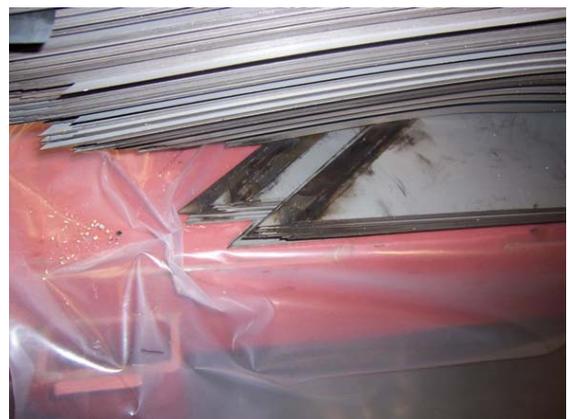
Root cause of gassing was attributed to a poor shielding design or reduced cross sectional area of core

Figures 31 A and B show the Core overheating. A is T21 and B is T 22
