# Transformer Chemistry Services[TCS]

**PREDICTIVE MAINTENANCE THROUGH TRANSFORMER OIL ANALYSIS**

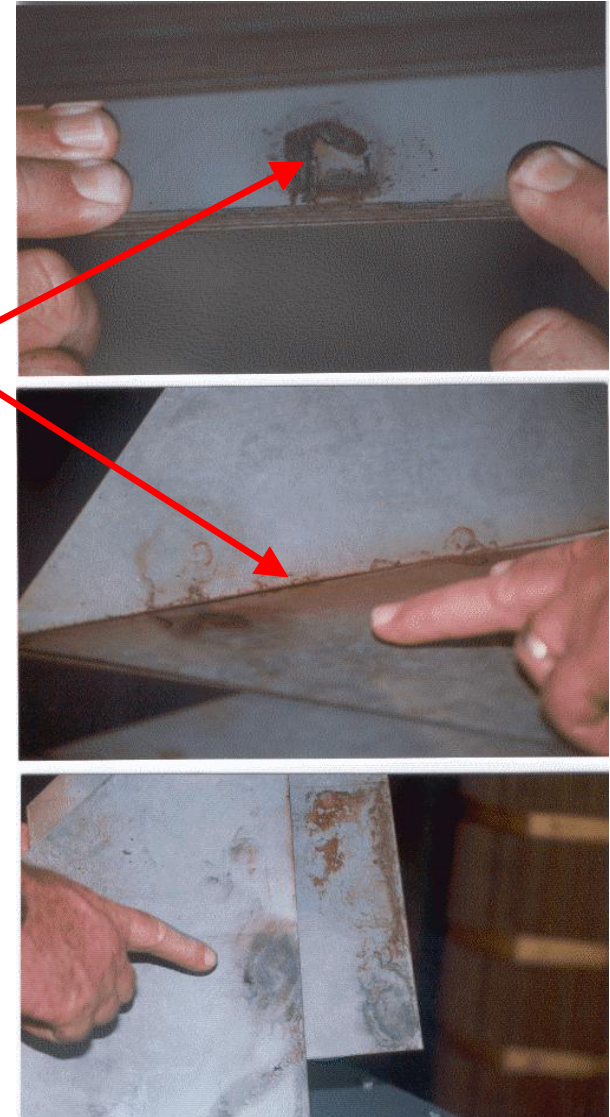
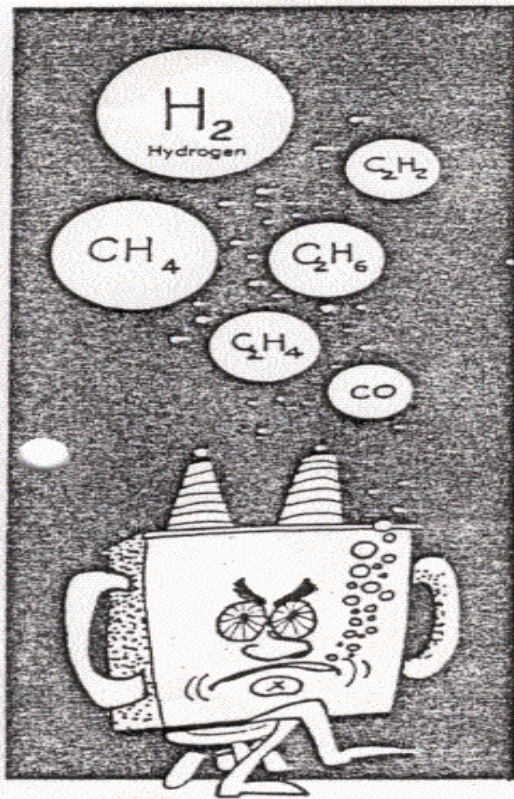
# Sapref Petroleum Refinery

Diagnosis: Partial Discharge(Corona)

Condition Code 4

Findings The core of the transformer was found to be delaminating due to corrosion caused by high humidity( 73 ppm water in oil)

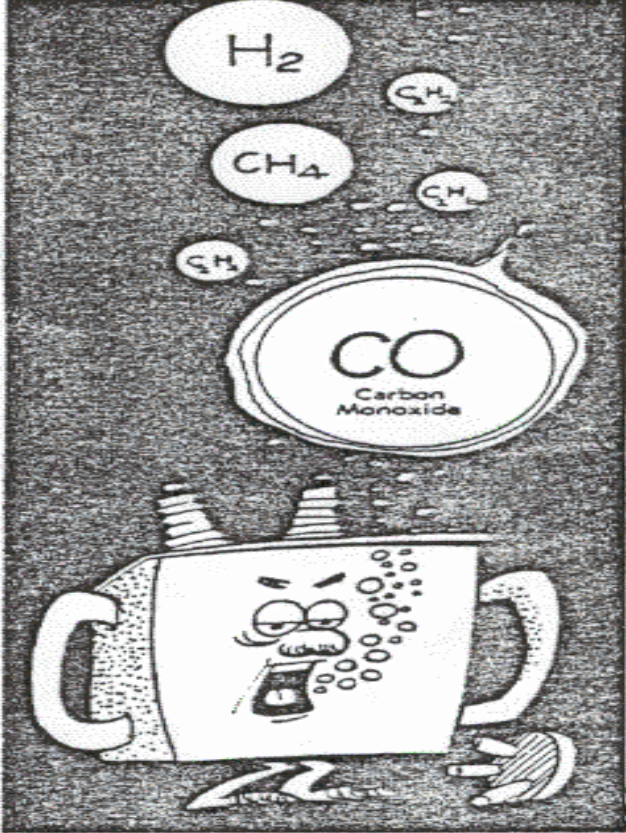
# Tongatt-Hulett's Refinery

Conduction and Ionisation (Partial discharge)  
Cellulosic Degradation-impending insulation failure

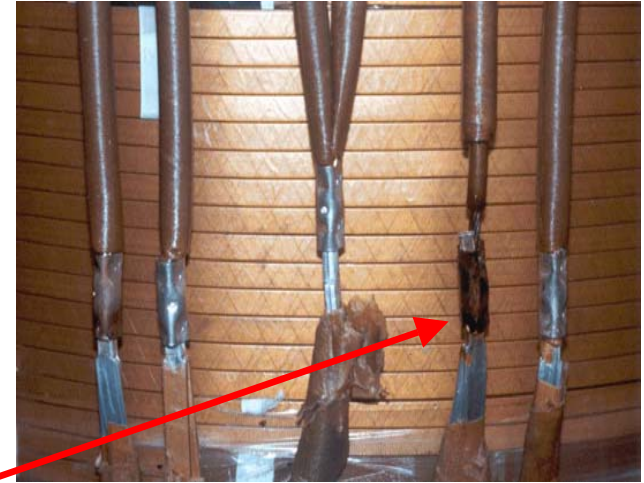
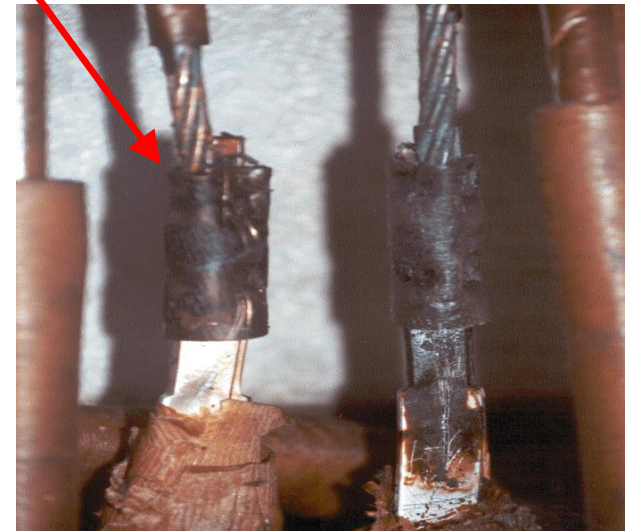
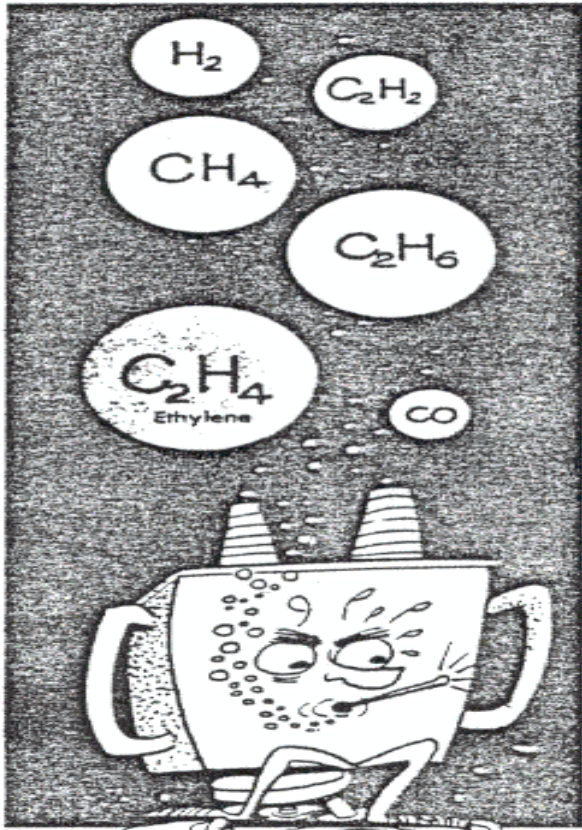
# UMGENI WATER

The DGA indicated a Thermal Fault 300-700 Deg C

*Findings:* Various Copper to Aluminium (bi-metal) connection's were found burned

The transformer was repaired at the Manufacturer cost, i.e First year warranty

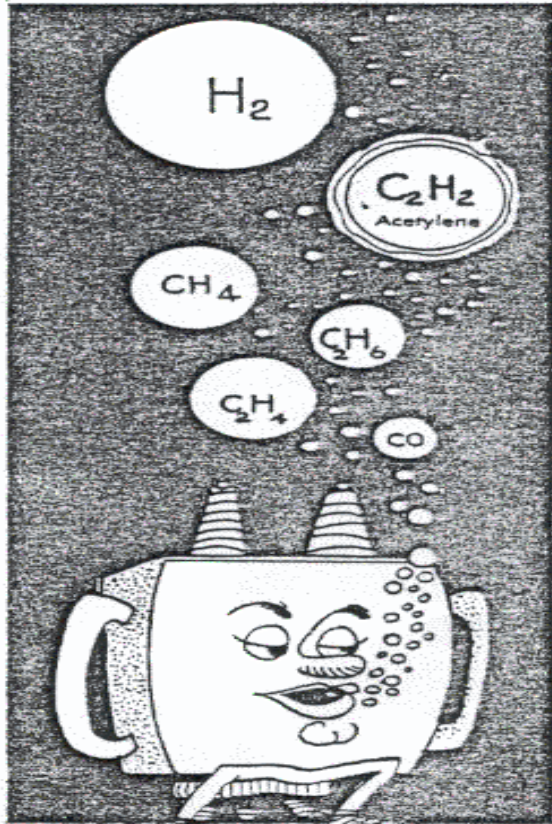
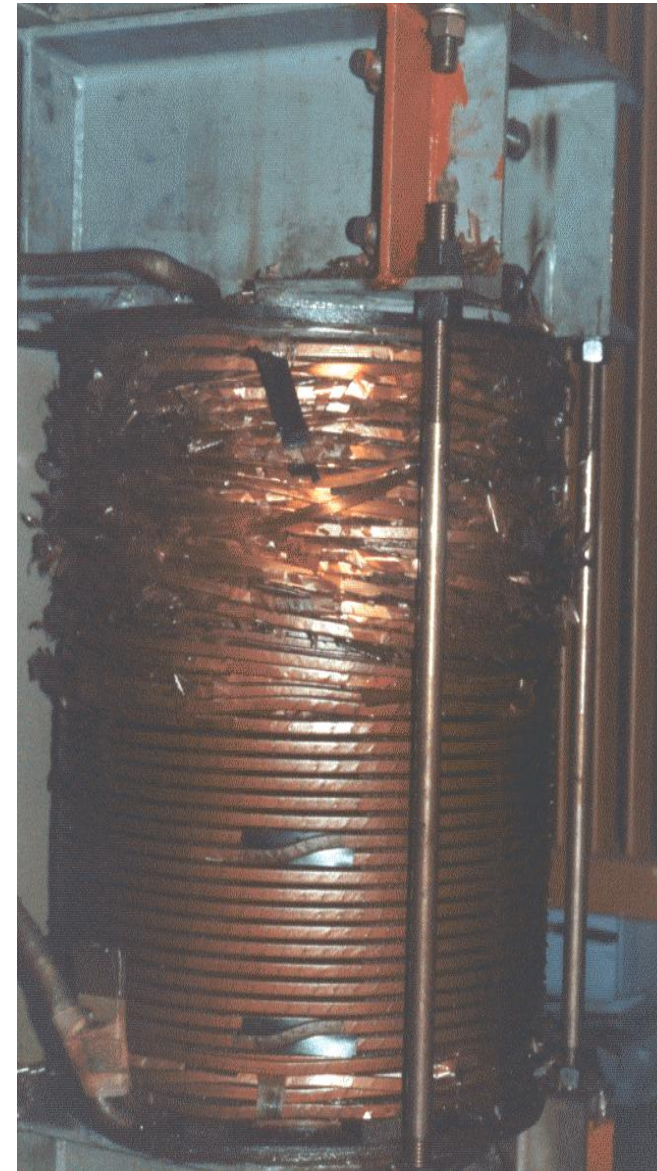
# NORDBERG SMELTER

The DGA analysis indicated a Discharge of High Energy(Arcing)

**Condition Code 4**

*Caution: In the event of a unit trip conduct a DGA before Re-energising*

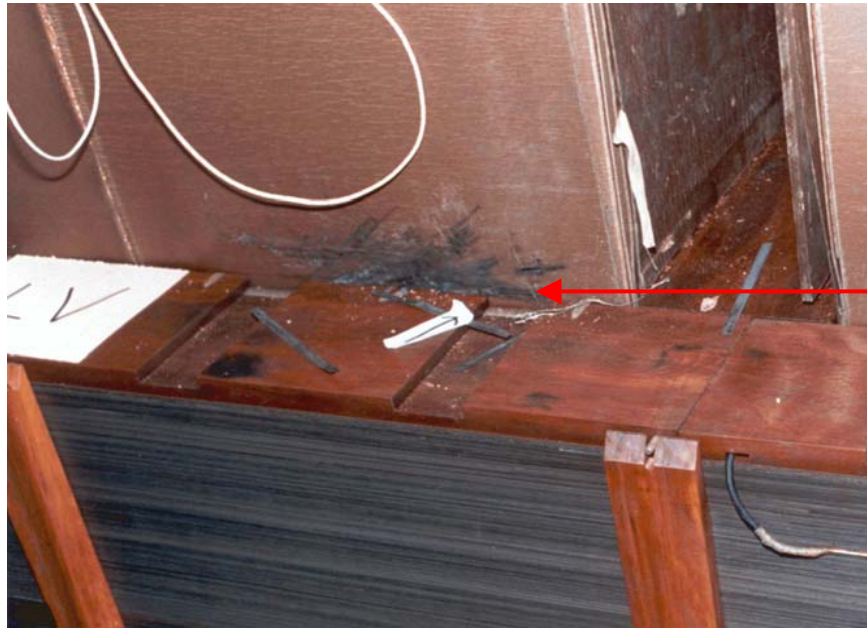
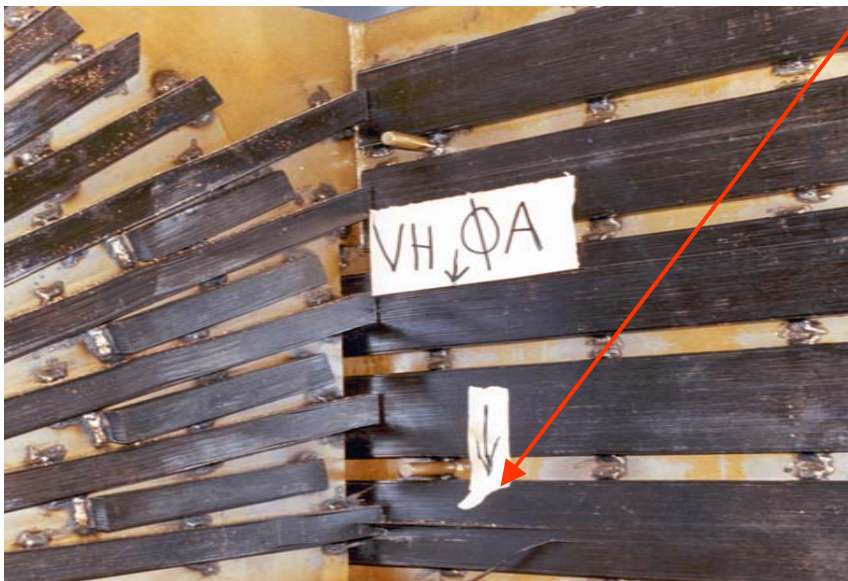
## ESKOM: Chivelston Substation

*Diagnosis:* The Dissolved Gas Analysis indicated a Thermal Fault Of High Temperature >700 DegC  
*Note: Calculated time to Buchholz activation: 2 years*

*Findings:* The core of this shell form transformer was found to delaminating

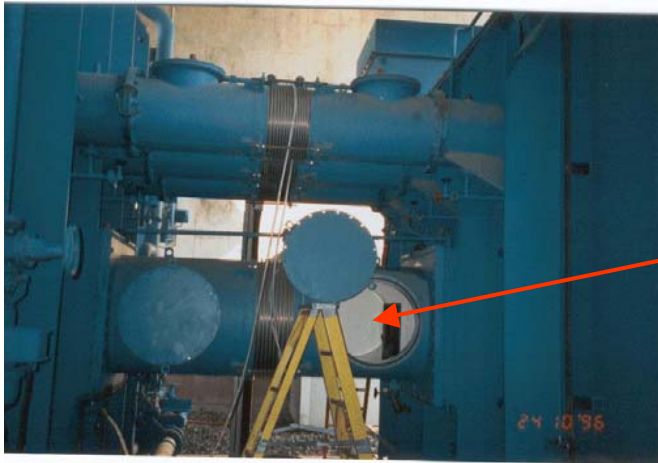
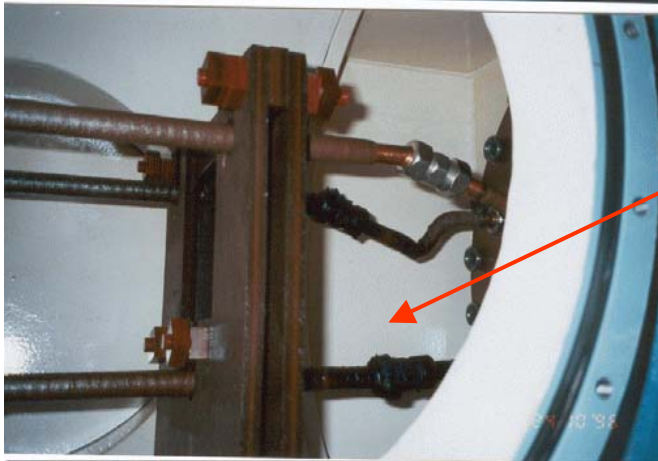
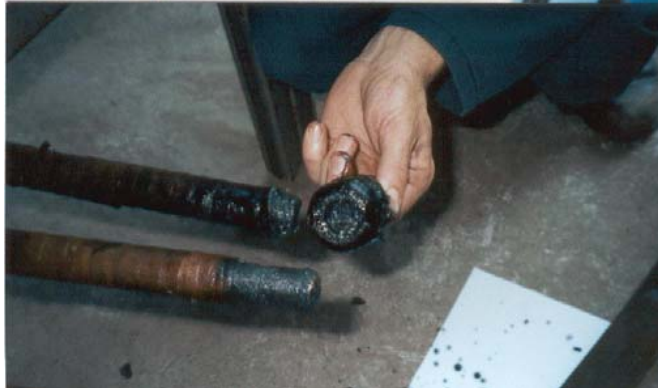
# HILLSIDE ALUMINIUM

***Analysis/Diagnosis:*** The Interconnected system Tripped on Buchholz 6 months after energising. The manufacturer suspected a Corona Fault on the cable housing. The DGA analysis indicated a Thermal Fault(300-700 degC) in the Bottom Chamber. **CONDITION Code 4**

***Findings:*** Burnt connections in the Bottom Chamber due to non-conforming quality control during installation

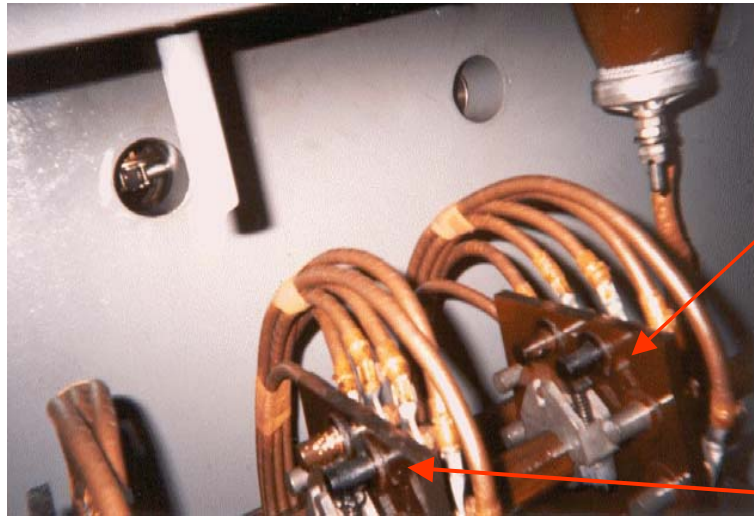
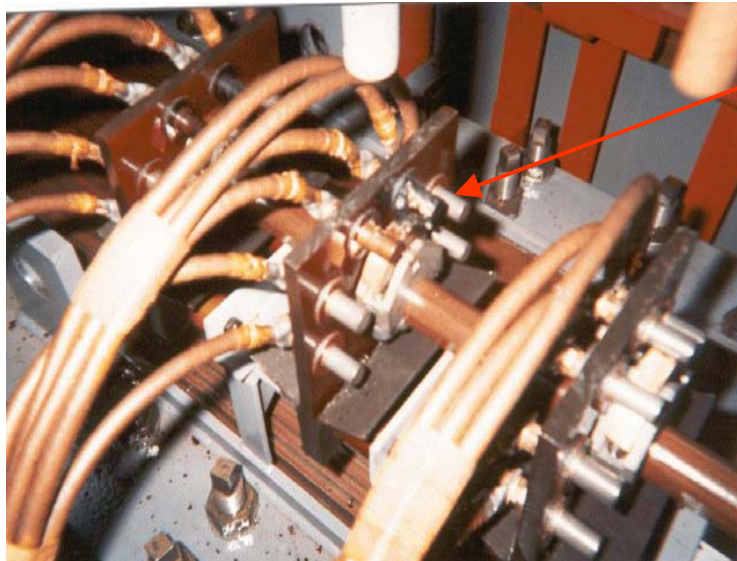
# ESTCOURT TLC

Discharge of High Energy due to failed Off-load Tap changer

All phases had burning

The inner contact ring of the center phase had failed.

*Note: The center phase of the tap changer was directly below the pipe from the conservator tank. i.e. Flow of oil was over this point*

The transformer was repaired on site and returned to service

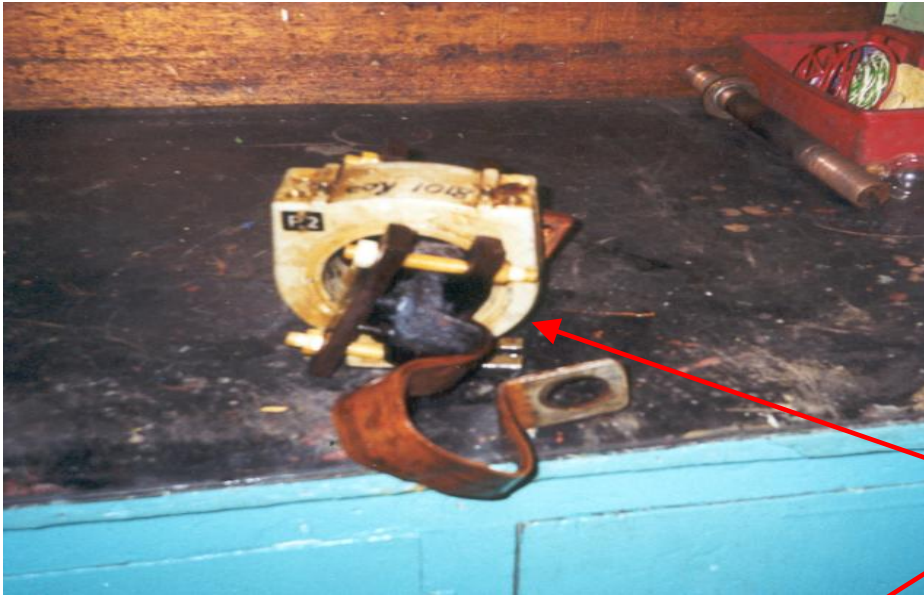
**BURNT CURRENT  
Transformer**

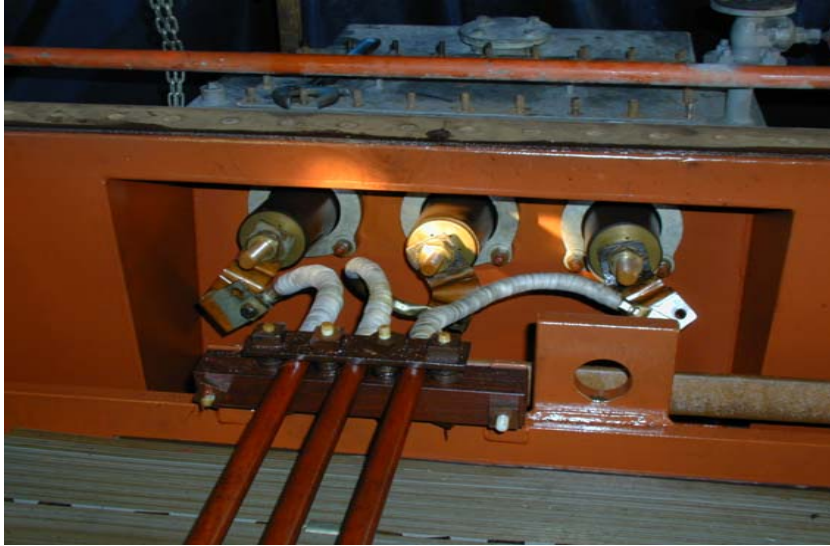
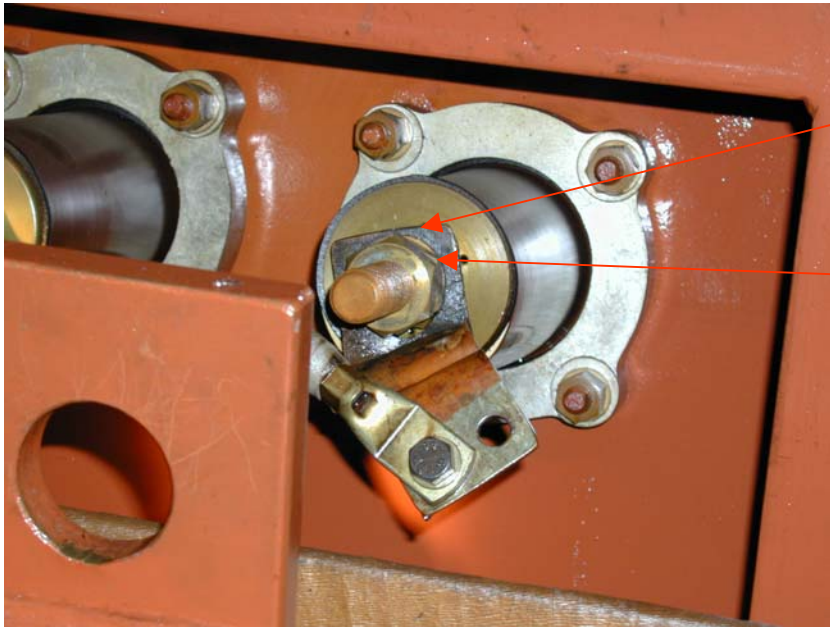
The DGA analysis indicated a Thermal Fault in the main tank.

The center and outside connections were burnt due to bad contact between the copper bar and the bushing stud. Closer inspection shows that stud/hole diameter of the copper bar was oversized so that only the points of the connection nut were making contact. This reduced the area of contact required for normal current flow conditions.

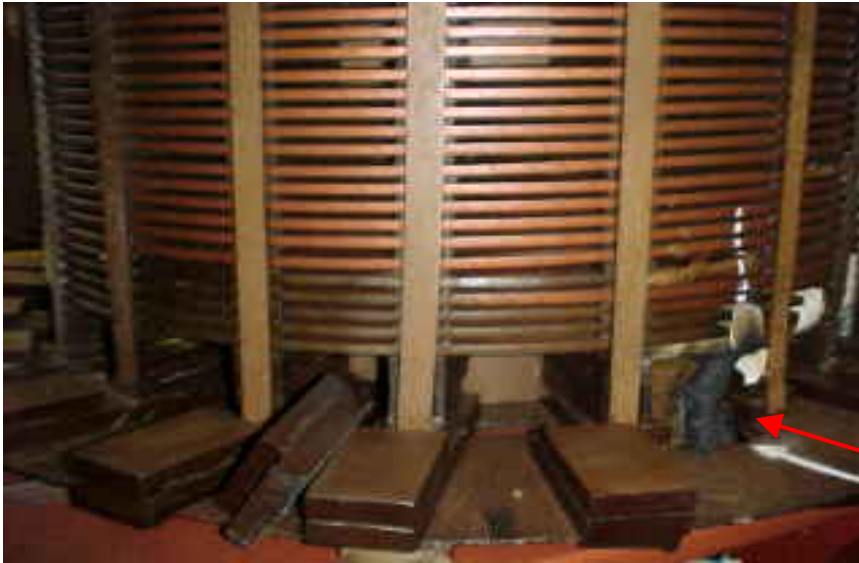
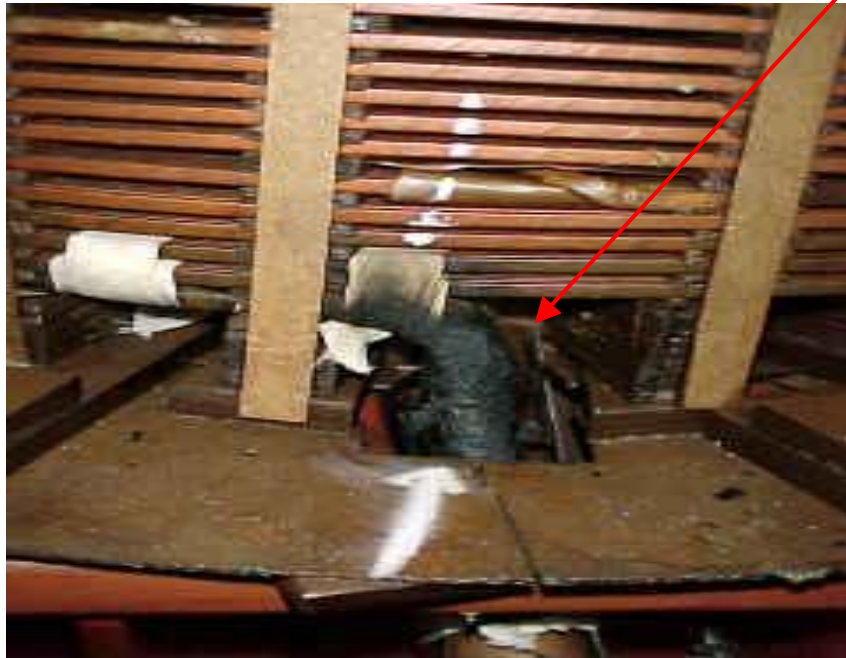
Burnt connection found  
Within the windings.  
Note: Windings removed at  
Repair facility

## Transformer sent to Works Facility

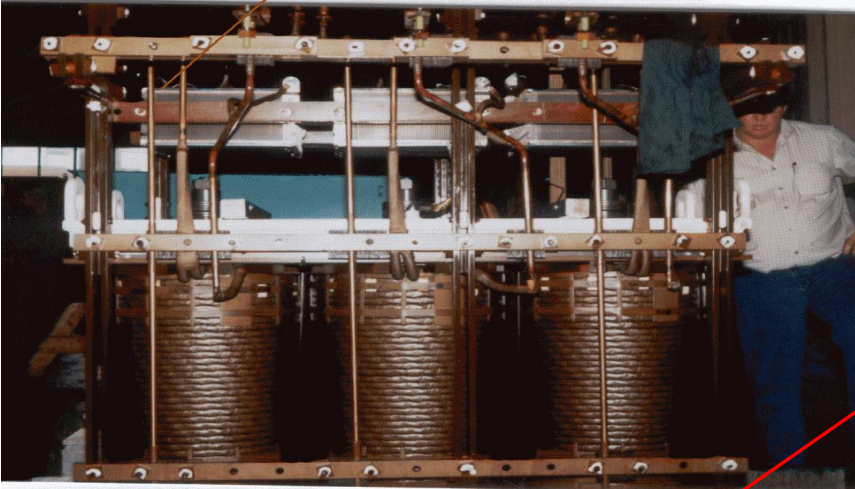
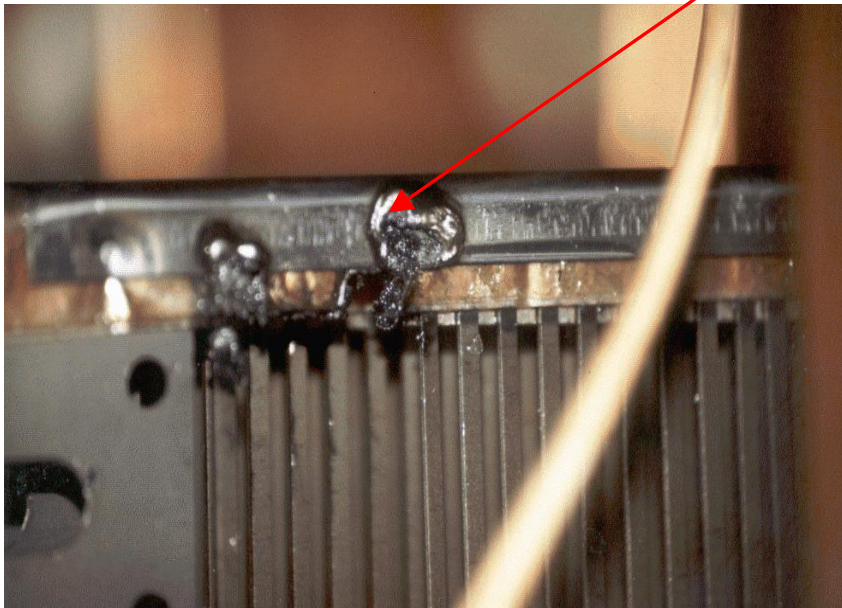
# Hillside Aluminum

*THERMAL FAULT OF OF HIGH  
TEMPERATURE RANGE > 700 Deg C*

**CONDITION 4** -Ethylene(C<sub>2</sub>H<sub>4</sub>)-Significant

**FINDINGS: Burning on the Resistor**

*CAUSES: Fourth Harmonic being amplified causing the transformer to be subjected to 10 times its rated current(milli seconds) i.e Design Fault System*

Burning occurring on resistor bank
