# Transformer Chemistry Services[TCS]

**PREDICTIVE MAINTENANCE THROUGH TRANSFORMER OIL ANALYSIS**

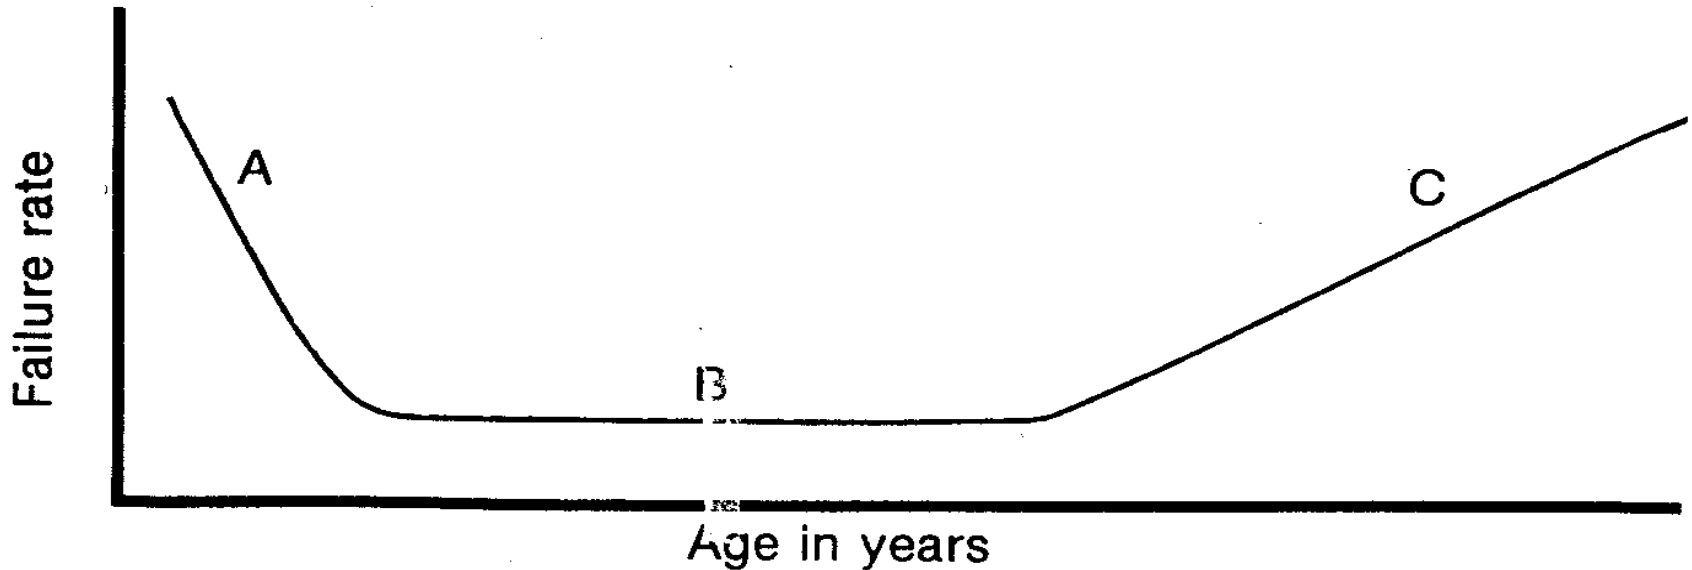
*Figure 1.76 - Transformer failure rate "Bathtub Curve": (A) is failures due to infant mortality; (B) is constant failure rate (random); and (C) is failures due to aging. (R. Sahu, "Using Transformer Failure Data to Set Spare Equipment Inventories"-1980).*

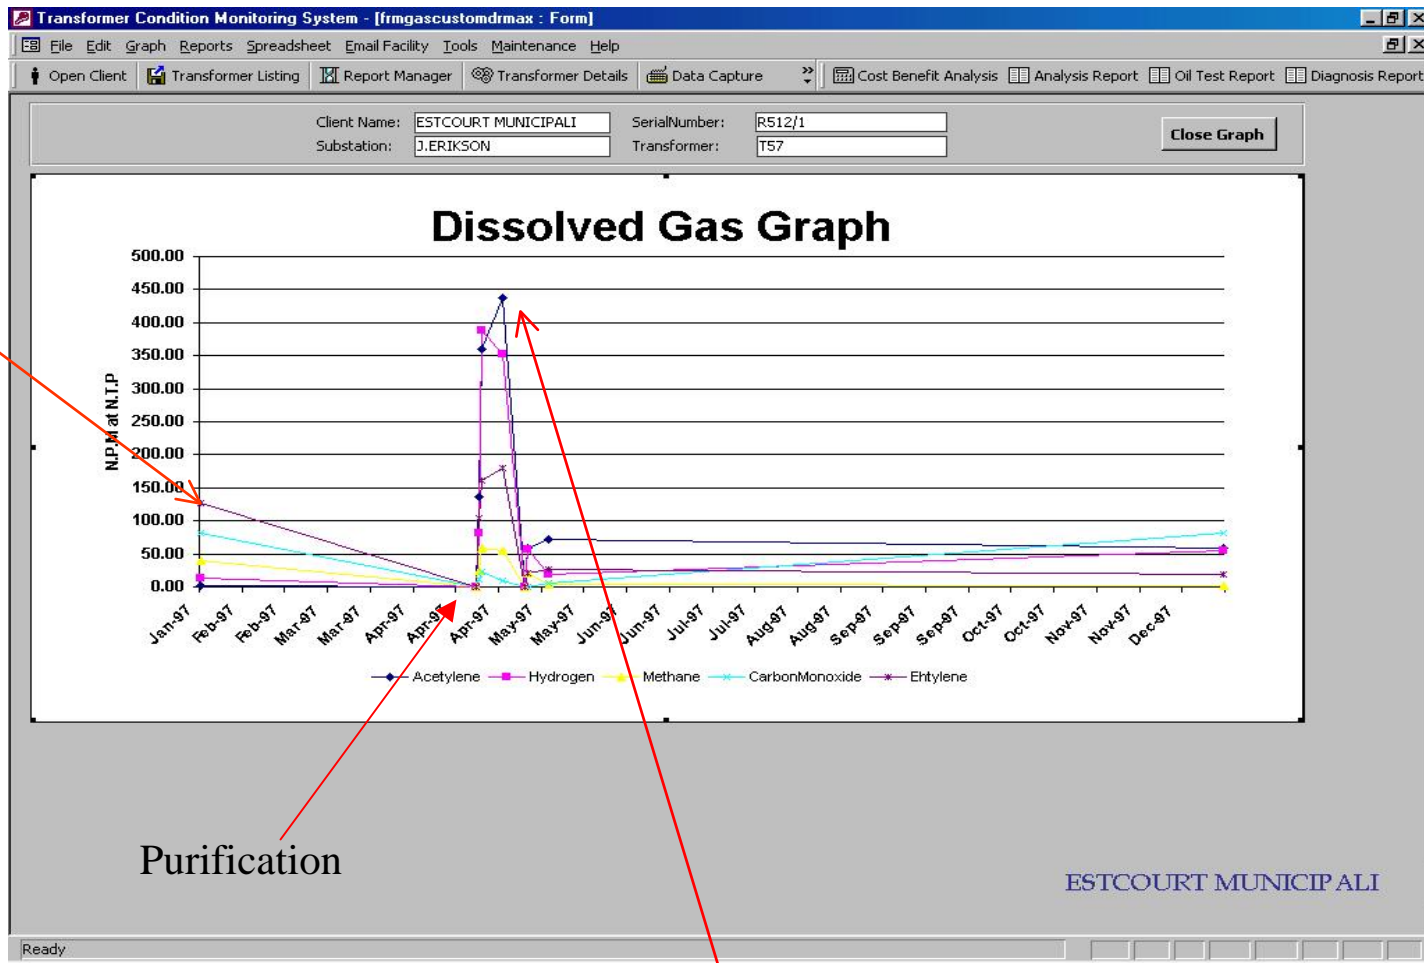
The DGA analysis at 21/07/1997 indicated a Thermal Fault  
The maintenance contractor recommended Power-on oil purification. i.e *highly dangerous and irresponsible as further damage is likely, with additional costs to the transformer owner*

The DGA analysis 30/04/1997 indicated a Discharge of High Energy(Arcing)  
The transformer was having Power-On oil purification at the time of the Buchholz Alarm

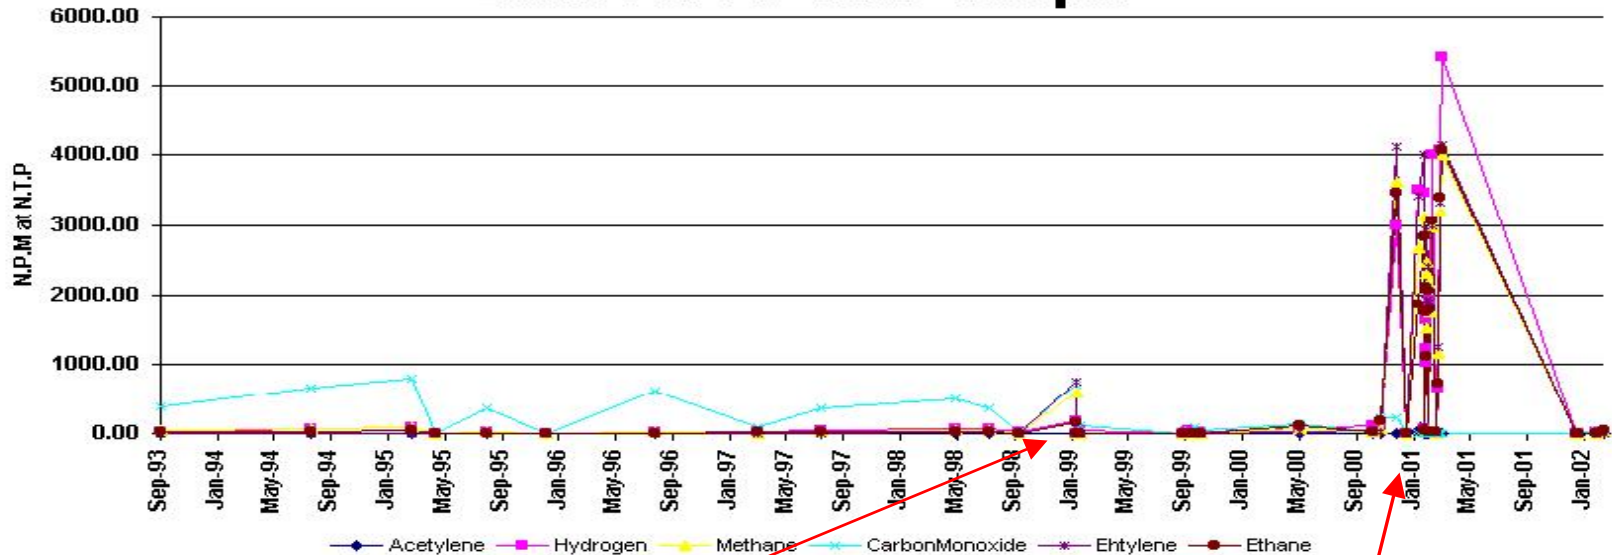
Unit Trip 11/01/1999  
DGA: Thermal Fault High  
Temperature  
Sent to works facility for repairs

DGA: 27/11/2000 Indicates  
Thermal Fault  
CONDITION CODE 4  
See DGA graph range

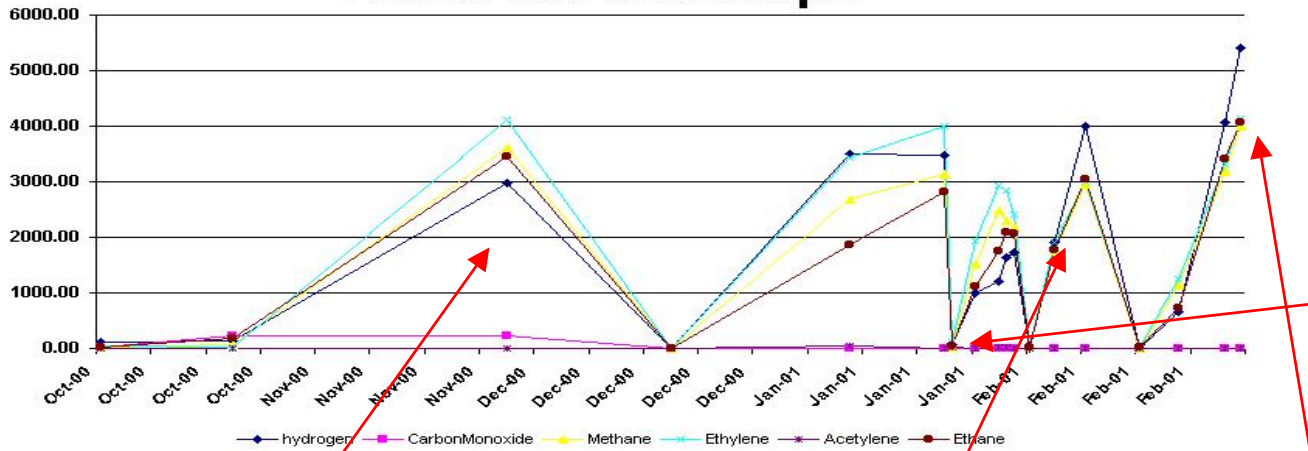
Purification  
To Degas

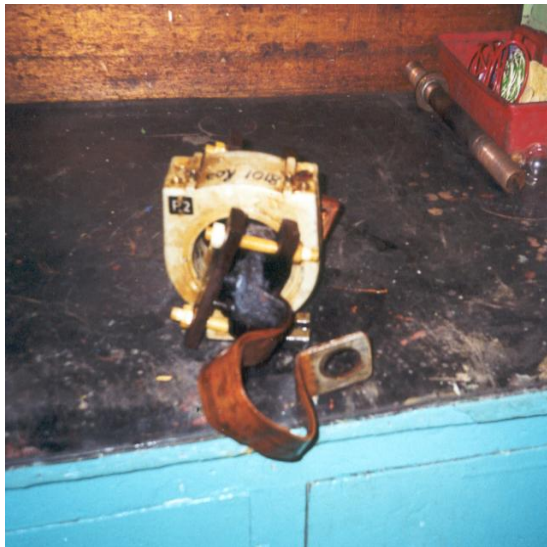
Burnt CT

**BURNT CURRENT  
Transformer**

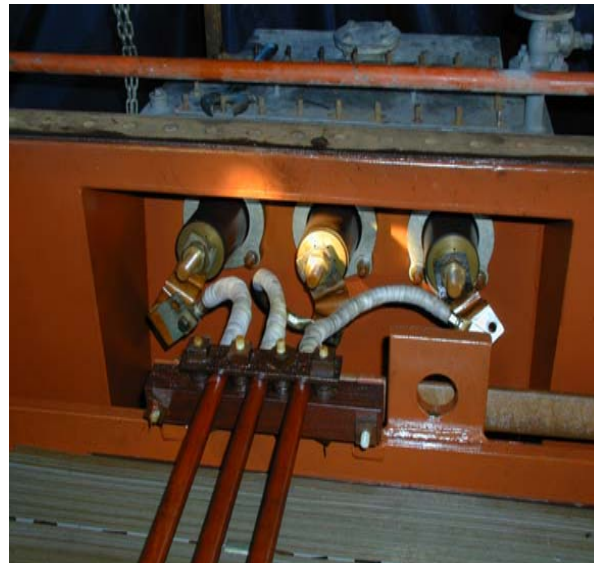
Burning HT

The center and outside connections were burnt due to bad contact between the copper bar and the bushing stud. Closer inspection shows that stud/hole diameter of the copper bar was oversized so that only the points of the connection nut were making contact. This reduced the area of contact required for normal current flow conditions.

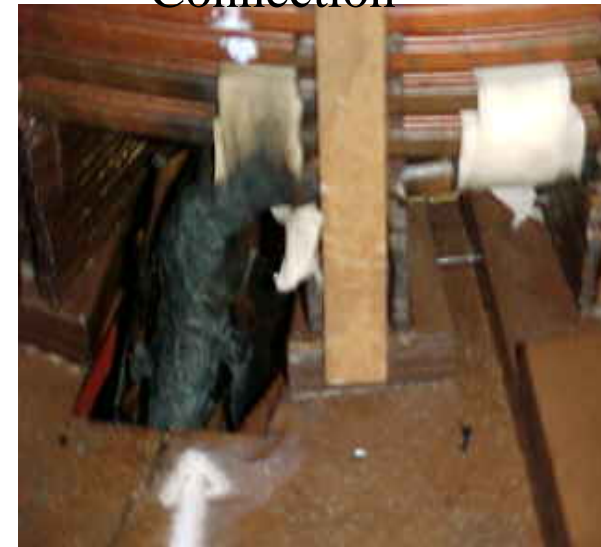
Burnt Internal  
Connection

Burnt connection found  
Within the windings.  
Note: Windings removed at  
Repair facility
