The Life of the Transformer is the life of its insulation system

Transformer Failure caused by contaminated insulating oil

Failure of 11/0.4 kV: 800 KVA Transformer

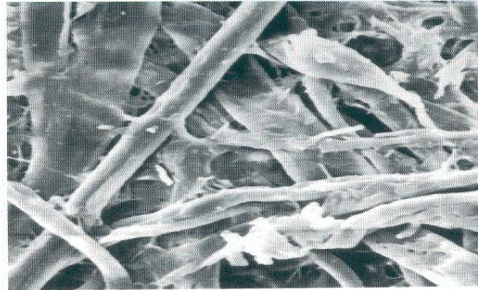
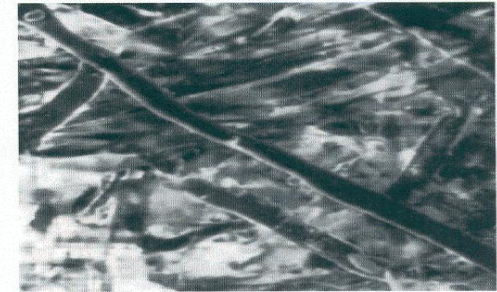
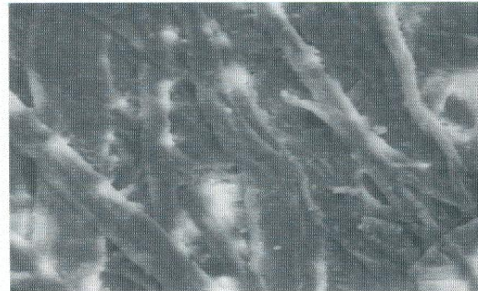
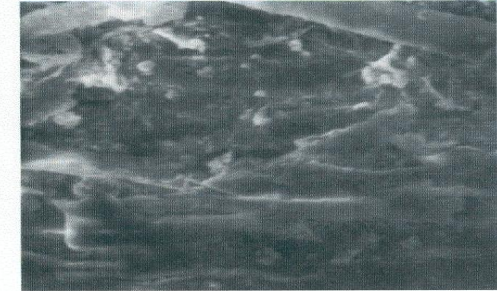
2 Your transformer's paper insulation acts just like the paper in your car's oil filter- it filters these decay products out of the oil and holds them, **DESTROYING YOUR TRANSFORMER'S PAPER INSULATION!**

Electron Scanning Micrograph of Kraft Pressboard Spacer at 250x.

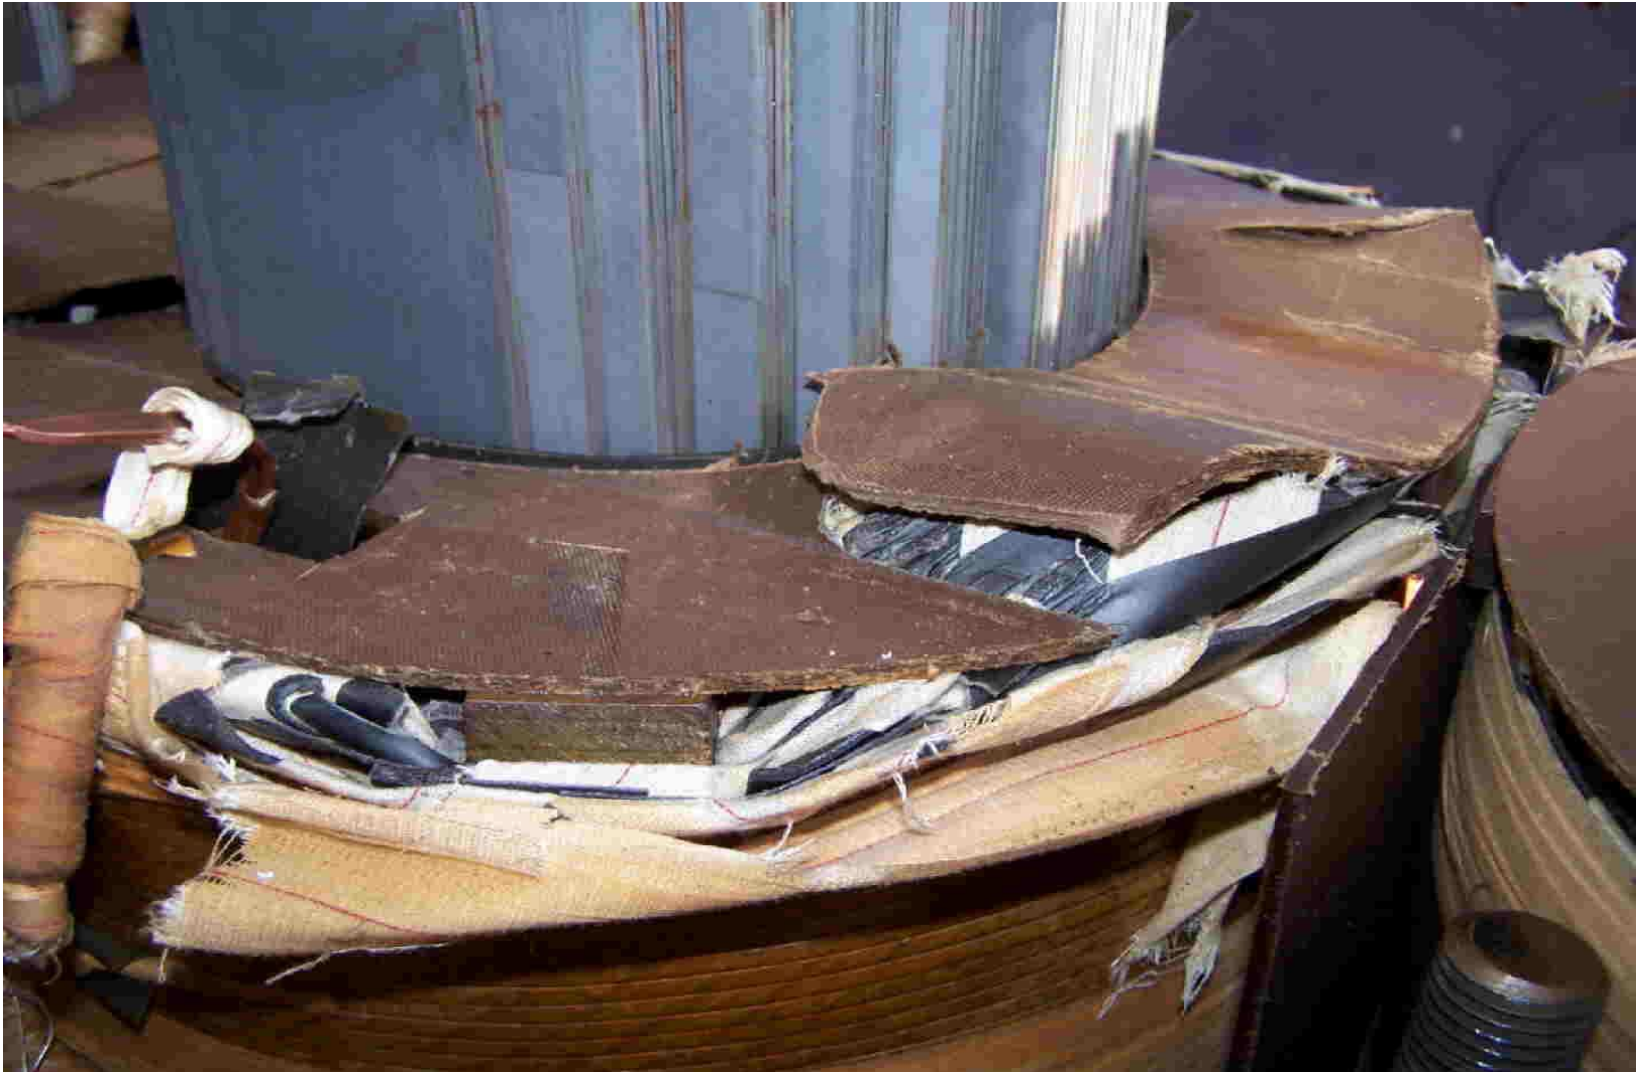
The transformer circuit breaker tripped 2-3 minutes
after Re-energising on load

The mechanism of failure is as follows.

The primary fault was a flash over on the center phase of the Off Load Tap Changer Mechanism

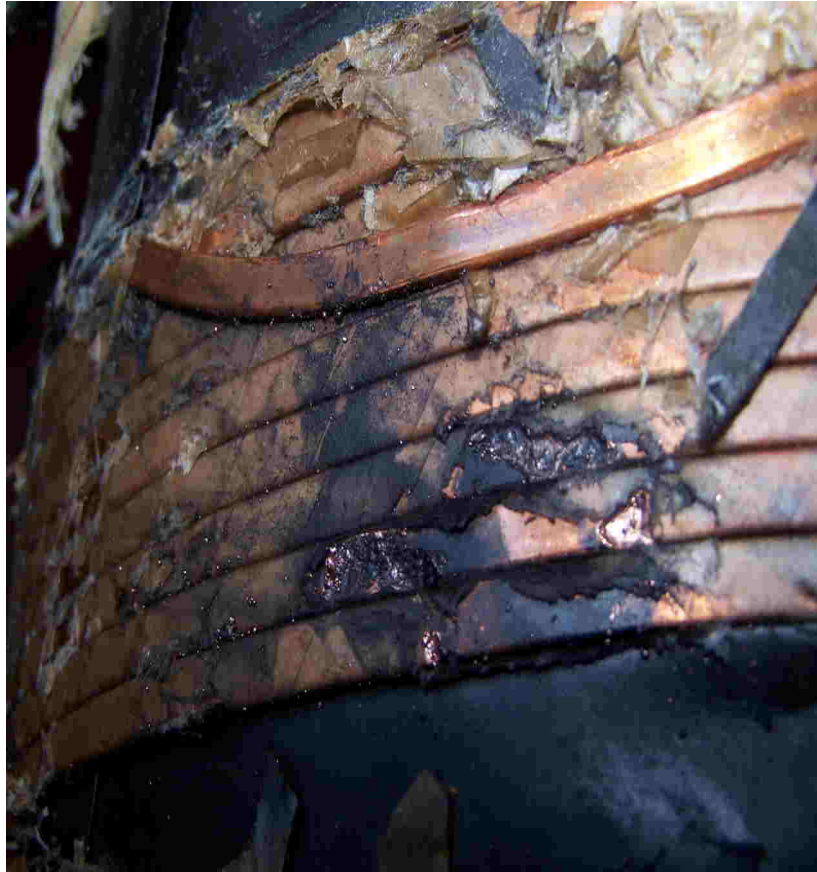
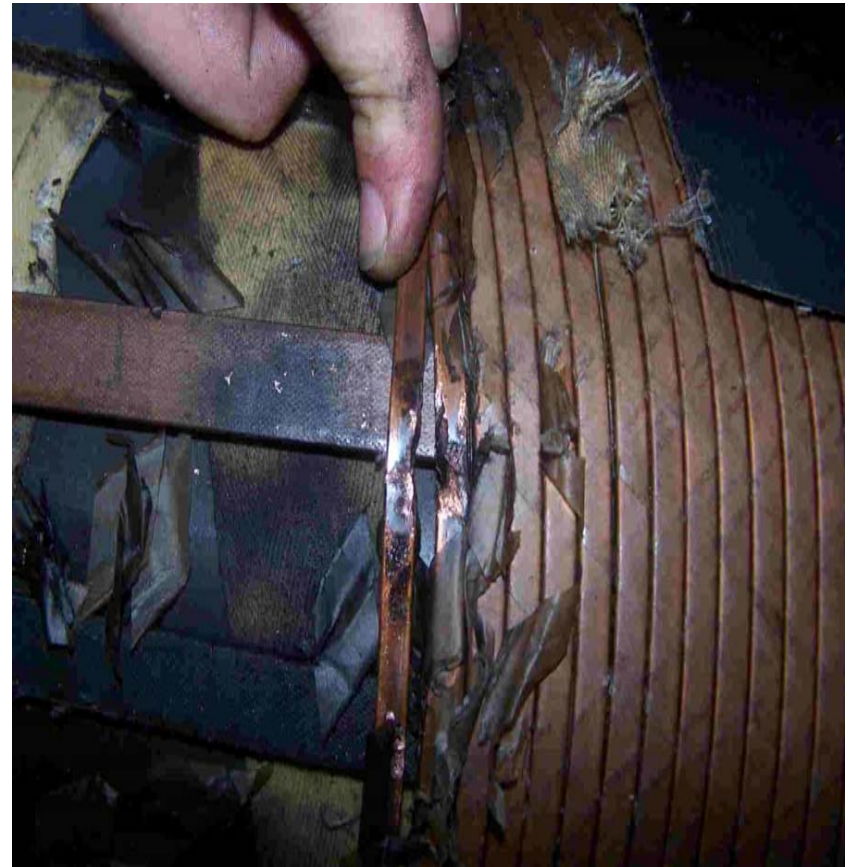
The vertical or axial force causes the low voltage and high voltage windings to shift with respect to each other, a condition called “telescoping” These forces make the windings take positions that will increase the magnetic flux of the system. If two windings are in series, the electromagnetic force varies as the square of current e.g. a short-circuit 20 times normal will produce 20^2 (or 400 times) the normal stress.
