Practical Experience Gained from Dissolved Gas Analysis at an Aluminium Smelter

Ian.A.R. Gray
Transformer Chemistry Services

The Hillside aluminium smelter is located in Richards Bay, 200 kilometers north of Durban, KwaZulu-Natal province, South Africa. The operation is fully owned and operated by BHP Billiton.

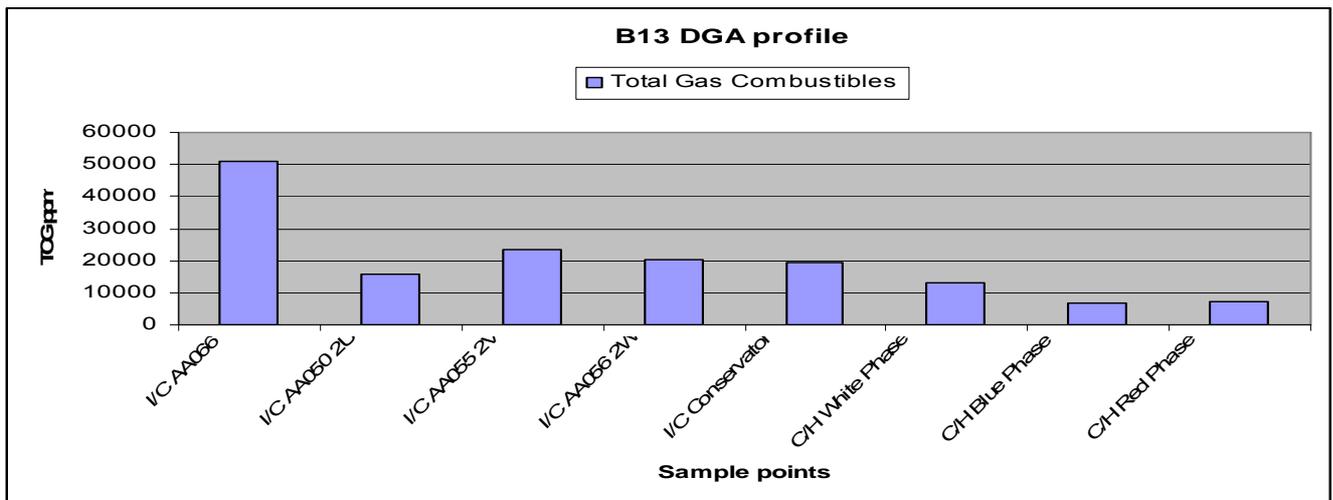
Table 13- DGA profile of samples

Samples were taken of the Buchholz gas and oil from the various sample points on the Inconnector system. The strategy was to use the DGA to classify the type of fault condition and to identify the compartment with the fault. There is very little oil circulation in the inteconnector so in theory the fault would be in the compartment with the highest gas concentrations. The Total Combustible Gas (TCG) levels as Listed in Table 13 show clearly that the location of the fault was not in the Cable Housing but at sample point (AA066), the main compartment between the transformers.

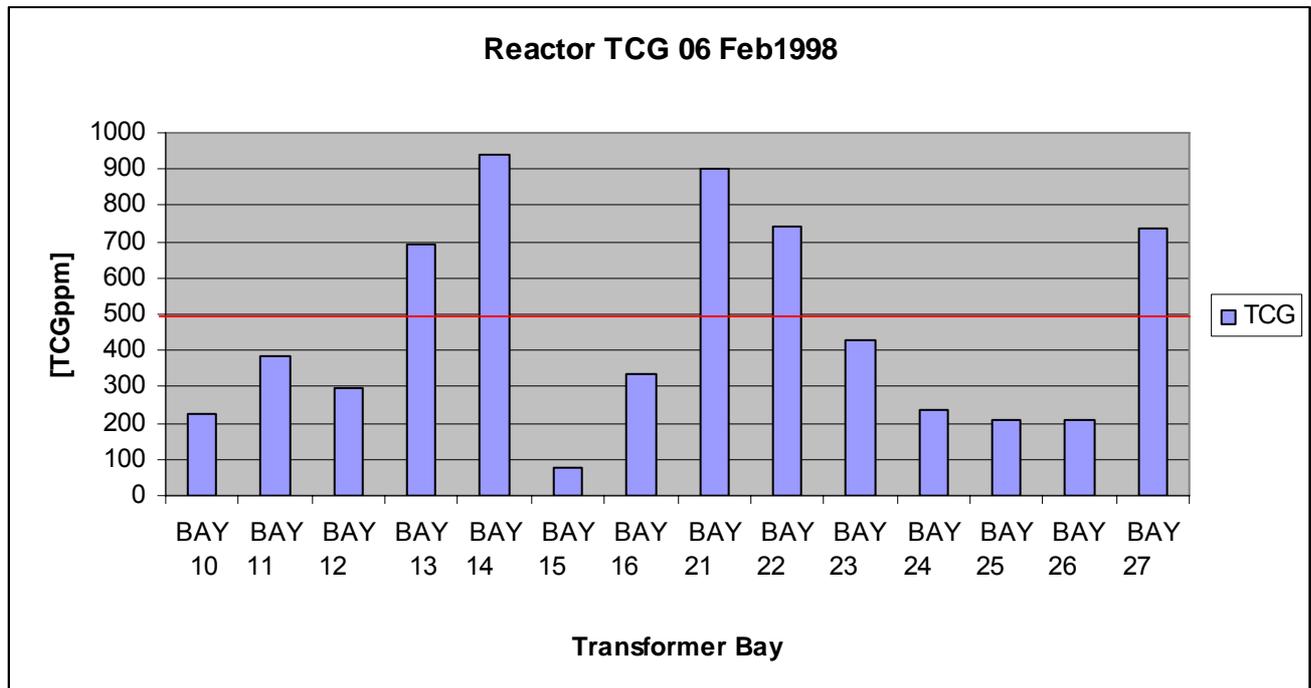
Table 16-Profile of TCG results at 06 February 1998

Routine DGA samples taken on 06/02/1998 showed a significant increase of Total Combustible Gas in a number of Reactors. See Table 16 showing the profile of results. The transformers from BAY 13: 14: 21: 22 and 27 showing the most significant increases.

The IEC 599 Ratio for transformers with Combustible Gas levels >500 ppm gave the fault condition as a Thermal fault of high temperature range >700°C.

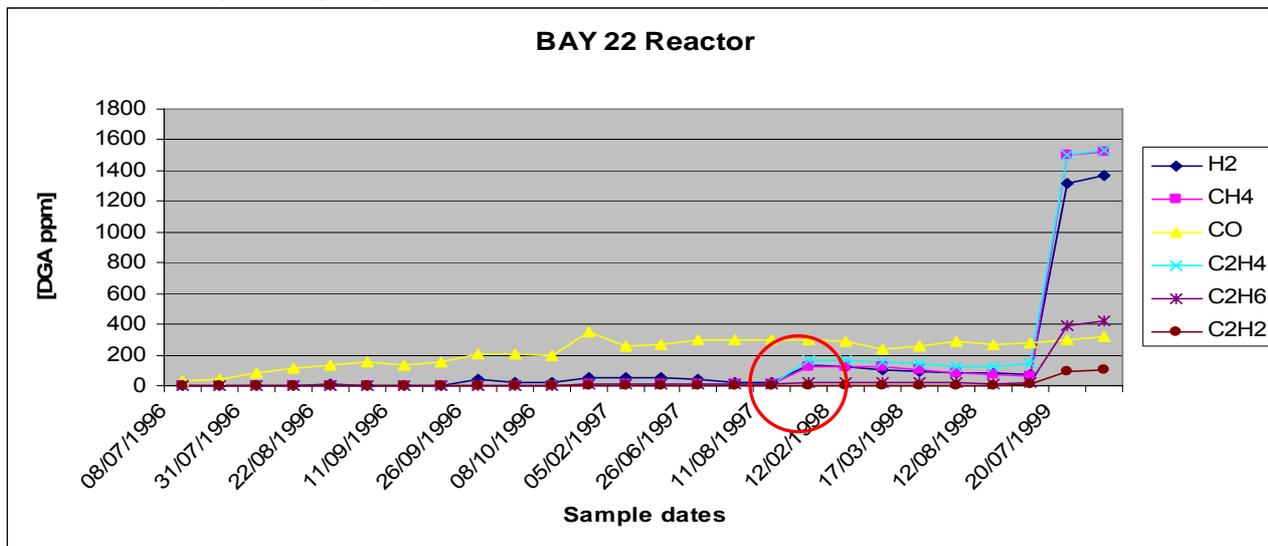
Figure 13 Graph trend of DGA data

All the reactor transformers were sampled on a frequent basis following the significant rate of DGA rise in February 1998. The frequency of sampling was decreased when it was observed that the Dissolved Gas levels had stabilised. However a sample taken on 20th July 1999 from BAY 22 Reactor showed a more than significant increase. A further sample was taken 24th July 1999 for confirmation and to monitor the Gas production. See Figure 13 giving the Graph trend. The results are listed in Table 17.

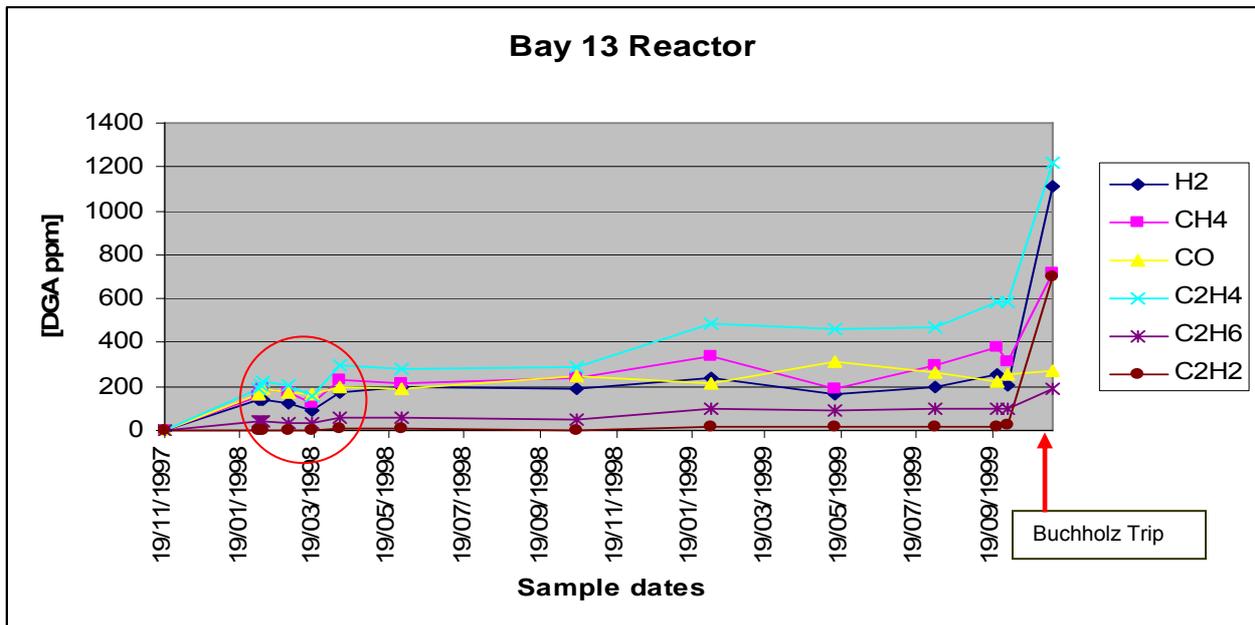
Figure 14 Graph trend

On the 05th November 1999, a gas trip was triggered by the Buchholz relay. The urgent DGA on the oil sample confirmed an arcing condition (IEC 599-Discharge of high energy). This transformer also had a gassing pattern showing a thermal fault with the initial indication in February 1998. See Figure 14 giving the Graph trend and with the results listed in Table 18.

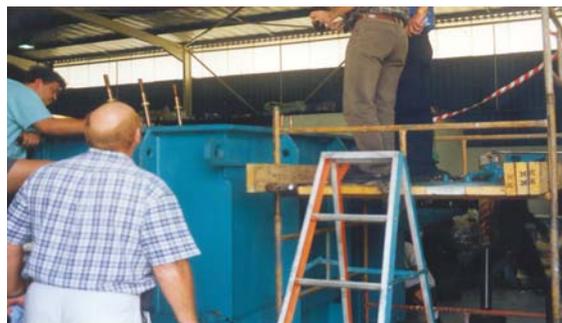
Figure 15-Reactor transformer being De-tanked at the Works facility

The transformer was removed to a Works Facility for Inspection and repairs. See Figure 15

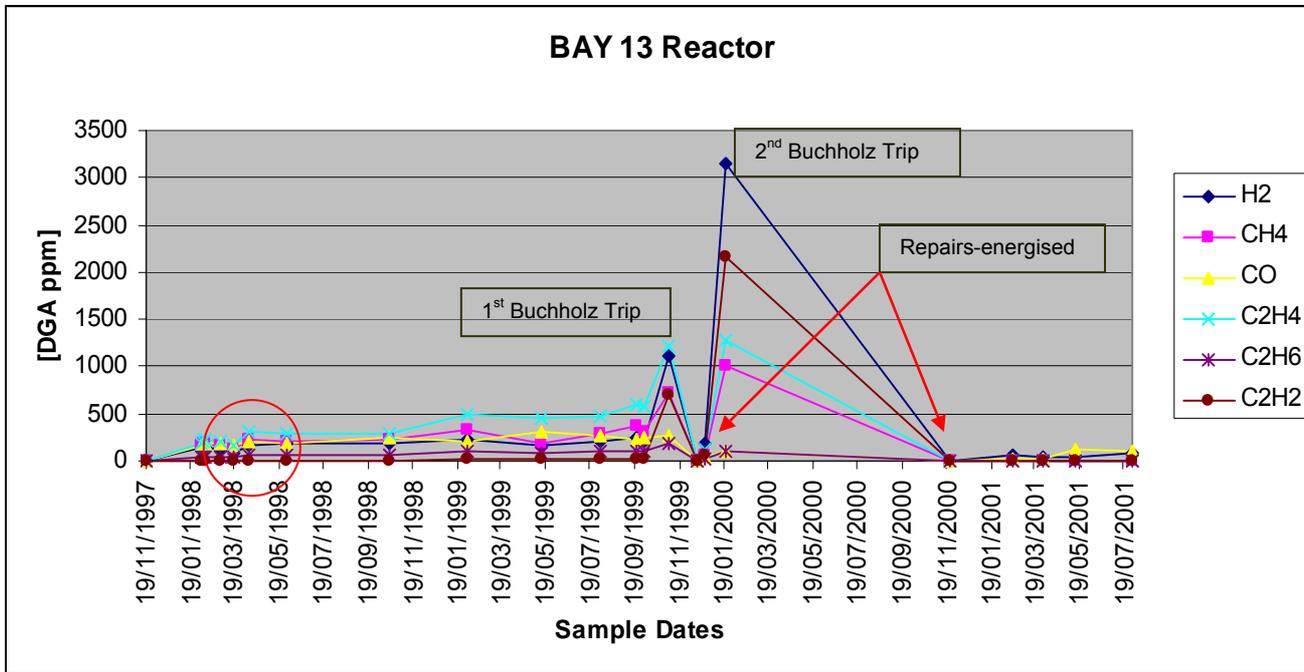
Figure 15-DGA graph trend

On the 21st January 2001, another gas trip was triggered by the Buchholz relay. The urgent DGA on the oil sample again confirmed an arcing condition (IEC 599-Discharge of high energy). It is interesting to note that the sample taken 24/12/1999 was already indicating a discharge of high energy due to the overstressing of the resistor bank. See Figure 15 giving the Graph trend. The DGA results from the 1st Buchholz trip are listed in Table 19.

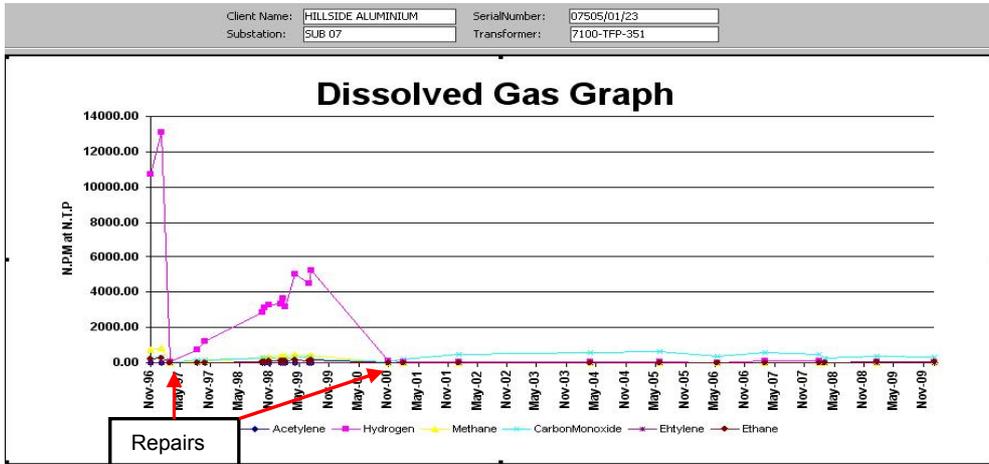
The transformer was repaired by the manufacturer in February 1997; however DGA samples taken after re-energisation showed that the repairs had not been effective. The unit was returned to the manufacturer in August 1999 for further repairs that were effective. See Figure 23 Showing the DGA trend which also acts as a timeline.

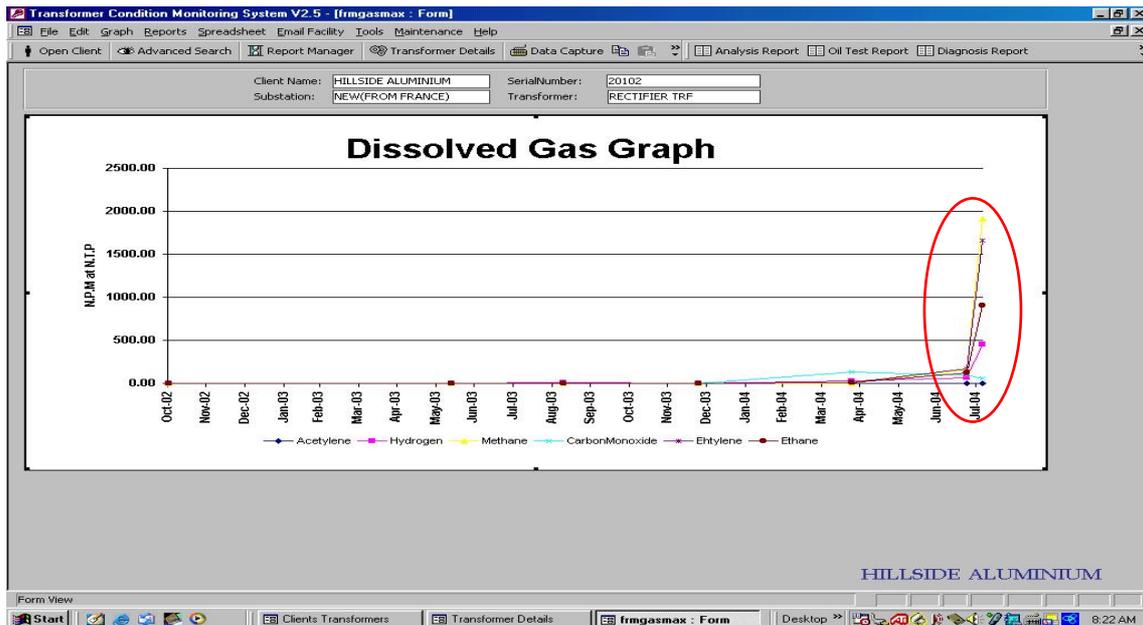
Figure 25-shows the DGA trend

The DGA on this transformer showed abnormal gas production of hydrogen, methane, ethylene and ethane about 20 months after Energisation. The fault condition was diagnosed as a thermal fault of medium temperature in the range 300°C-700°C. The recommendation was to remove from service for Inspection. See Table 19 giving the name plate data and Figure 25-shows the DGA trend.

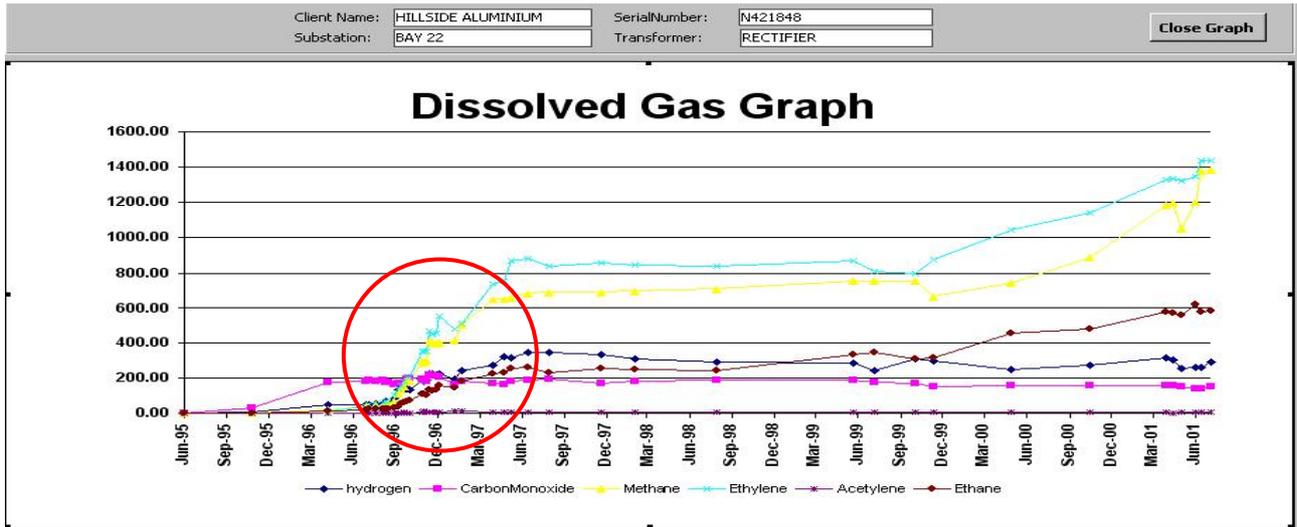
Figure 25-DGA trend up to July 2001

The manufacturer's contention was that, although this was not a normal gassing pattern it was not serious enough to warrant removing the unit from service. The manufacturer's in-house expert advice was to monitor the gassing pattern until exponential increase was seen.

The exponential rise can be seen from 1996 to 1997. See Figure 25.

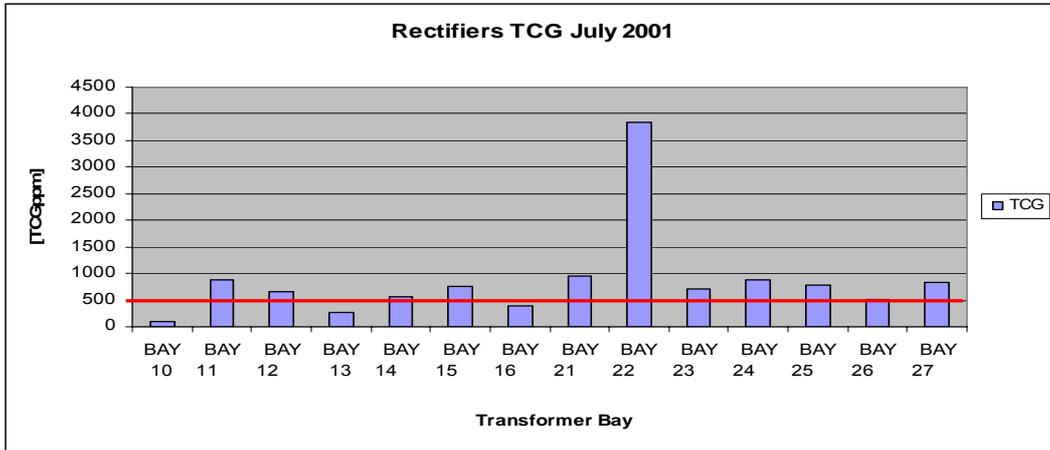
Figure 26-TCG profile for Bay 1 & 2 Rectifiers

This transformer was ranked as having the highest risk of failure, based on the DGA-Total Combustible Gas profile-See Figure 26 showing all Rectifier transformers at July 2001.

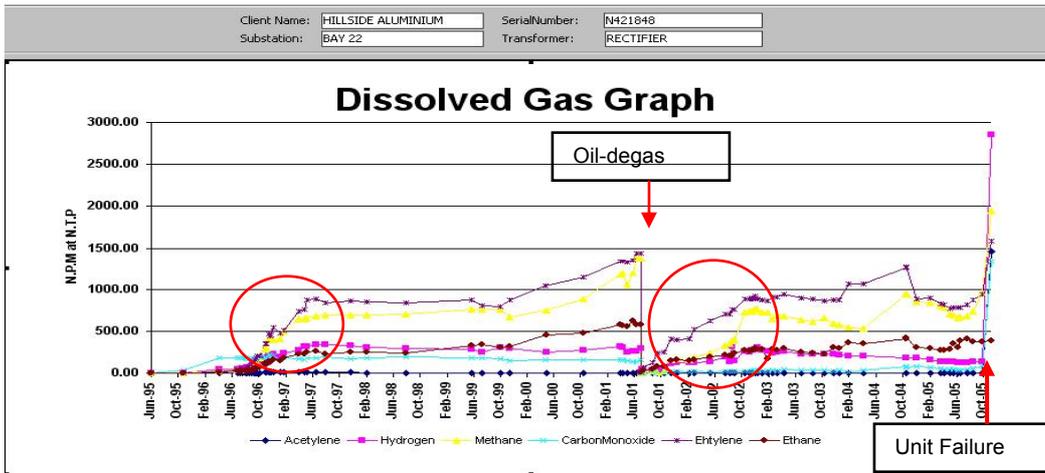
Figure 27-DGA-Profile

It is interesting to note the gas production after July 1997 showed only a slight rate of rise. See Figure 27.

However, after the oil de-gassing in July 2001, the same phenomenon of exponential gas production followed by a leveling off was seen. See Figure 27. This can be explained in part by the IEC 60599 code that reports that there can be gas diffusion losses for in service equipment. However, there is no agreement concerning the magnitude.

At 16:32, on the 18 November 2005, Transformer T22 failed catastrophically. An urgent DGA sample confirmed that a discharge of high energy (Arcing) had occurred. See Figure 27 showing the DGA trend.

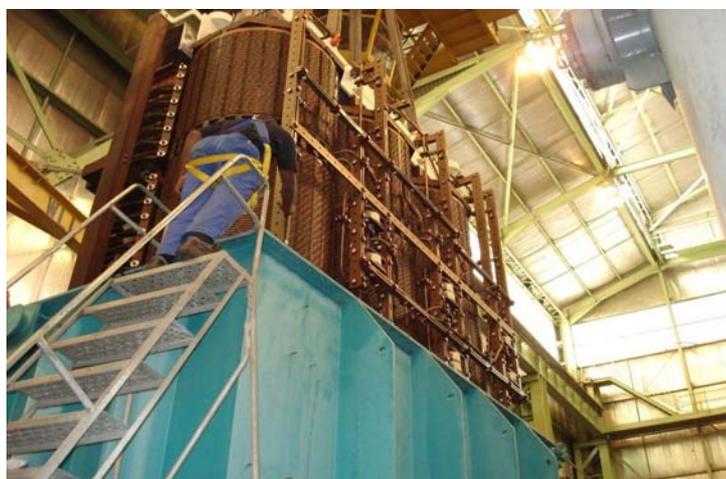
Figure 28-Transformer De-tanking

On the 21-12-05 the transformer HV and LV winding on the ‘A’ phase were removed and the core exposed. Figure 28 shows the transformer being de-tanked at the works facility as part of the failure investigation
